Rework in Projects: Learning from Errors

Ekambaram Palaneeswaran¹ and Muthukaruppan Ramanathan² and Chi-ming Tam³

CASE – 1: LATE DISCOVERY OF SETTING-OUT ERRORS

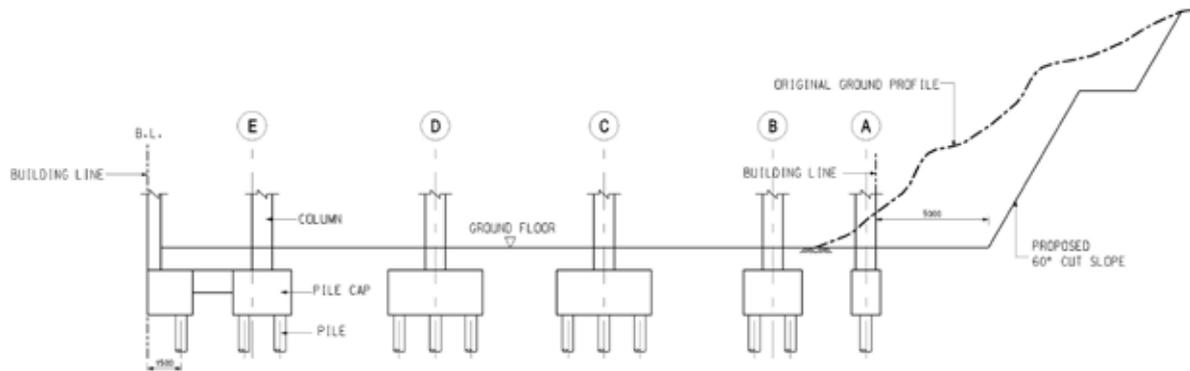
Figure 1.1: Design Intent

Figure 1.1 portrays an indicative cross-section of the design intent and Figure 1.2 portrays the piles as constructed with 3 meters offset of setting-out error. Upon completion of pile driving, chosen piles were load tested and the local authority granted consent to proceed with excavation and pile cap works. Subsequently, the superstructure contractor excavated for pile cap construction and the error was discovered as piles had been driven-in at wrong locations. The project manager instructed both the contractors (i.e. the two designated for foundation and superstructure works) to carry out a joint survey and the foundation contractor confirmed that they had wrongly set-out the building outline and that consequently, all the longitudinal gridlines and piles are also not in correct positions. Upon the late discovery of this error, the project manager immediately issued a 'Certificate of Non-Completion' to the foundation contractor. Additional unwarranted impacts included design and construction rework, the time and cost impacts, need for additional resources and wastages.

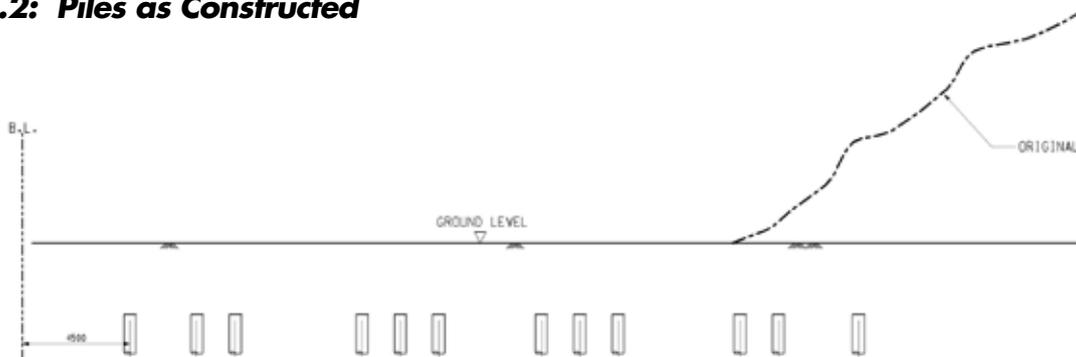
**Figure 1.2: Piles as Constructed**

In this reported case, the foundation contractor commenced the foundation works soon after the contract was awarded. Initially, the foundation contractor had incorrectly set-out the building outline. Due to some poor managerial practices and inadequate quality management in his part, this error was not detected and rectified immediately. Consequently, all the longitudinal gridlines (i.e. alphabetical notations A, B, C, D, and E as in Figure 1.1) and the piles along those gridlines were wrongly set-out, offsetting by 3 meters away from their intended positions towards the hillside. Subsequently, all the piles were constructed in wrongly set-out locations. Apart from this undetected error, the 3-months

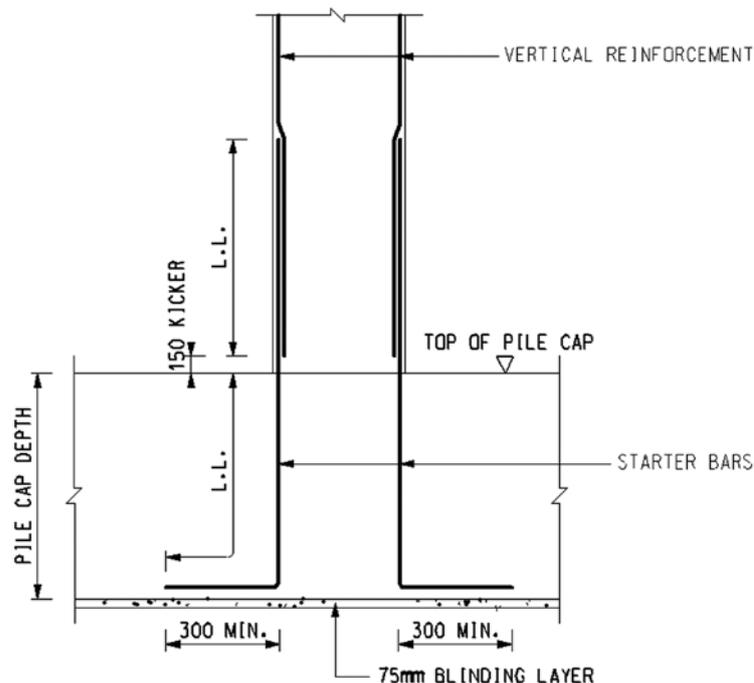
Figure 2.1: Typical Detail of Column Starter Bars (Contract Drawing) N.T.S.

Figure 2.1 portrays the standard arrangement for reinforcement details for the column starter bars. According to this standard practice, the reinforcement bars should be taken down to the pile cap bottom level. Besides, the

embedment length of "L.L." (i.e. abbreviation for tension lap length) requirements should be met. According to this arrangement, "L.L." should include a minimum of 300mm L bend, and the minimum lap length (specified elsewhere) shall be 46 times the bar diameter. For example, considering a normal pile cap of 1.5 meter depth and 40mm diameter of column reinforcement with a 50mm cover, corresponding "L.L." is 1840mm (i.e. 46×40), and the available vertical length within the pile cap would be 1370mm (i.e. $1500\text{mm} - 50\text{mm cover} - 80\text{mm for 2 layers of bars each 40mm diameter}$), whereas the remaining 470mm would be provided horizontally as an L bend. In such normal cases, the column bars will reach the pile cap bottom. However, from structural point of view, the column bars need to be embedded into the pile cap only for the required tension anchorage length, and it is not necessary that bars should reach the bottom of pile cap, unless there are some special demanding requirements.

In this multistory building project, pile caps for the main tower were of 4m deep and the contractor intended to embed only "L.L." into the pile cap, which was 1840mm for the 40mm bars. As the pile caps were deeper than usual, the intended anchorage length could not reach the pile cap bottom. Moreover, for the constructability reasons, the contractor had proposed to concrete the cap with three horizontal construction joints (CJ) (with three parts of 0.7m thick and one part of 1.9m thick layer). Thus, CJs were formed at depths of 1.9m, 2.6m and 3.3m from the top of the pile cap. In this case, the starter bars would not pass through any of the CJs. But the structural engineer expected that the starter bars would be taken down beyond the CJs and preferably up to the pile cap bottom level. Conversely, the contractor assumed that according to the contract drawing, only tension anchorage length would be provided into pile cap and the starter bar need not be

The concerned project was of a special situation in which the typical details are not suitable. Given the large size of the pile cap, concreting in several pours was expected. Necessary precautions of such piecemeal concreting had been included in the concrete specifications. But the specifications of typical details were not modified to suit the deep pile cap. However, the experienced contractor anticipated that he would be asked to take the bars down to the pile cap bottom. Hence, he raised the issue ahead of steel bar installation. Thus, the error discussed herein came to light in the initial stages of superstructure contract work and hence serious rework and wastages were avoided.

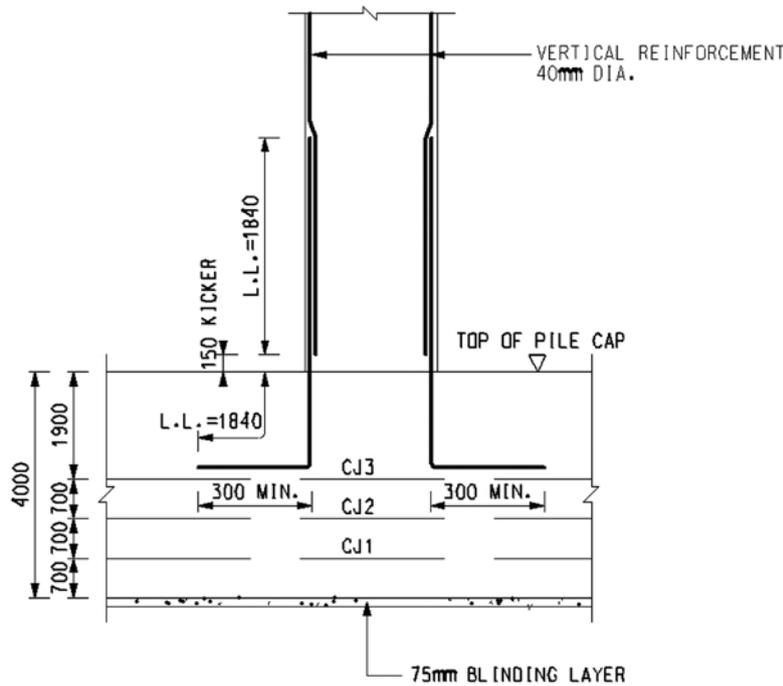
Figure 2.2: Contractor's Interpretation
(Contractor's Proposed Construction Joints Inserted) N.T.S.

extended down to the cap bottom. The contractor's interpretation is portrayed in Figure 2.2.

In this project, the pile cap is 4m deep and hence CJs were necessary for constructability. The starter bar detail was ambiguous in the contract drawing and hence the erroneous assumption was made initially, it was subsequently considered as desirable to extend the starter bars passing through the CJs. Consequently, the engineer had to convince the project team on his intended requirements for taking the bars down to pile cap bottom. If the intention of providing the starter bars up to the pile cap bottom had been expressed in an unambiguous way (e.g. with relevant cautionary messages), related claims and variations could have been avoided. Earlier, the project quantity surveyor agreed to the contractor's interpretation. However, the engineer insisted that the bars
