Surveying & Built Environment

A Special Commemorative Issue Marking the 80th Anniversary of the Battle of Hong Kong

Marking the 80th Anniversary of the Battle of Hong Kong

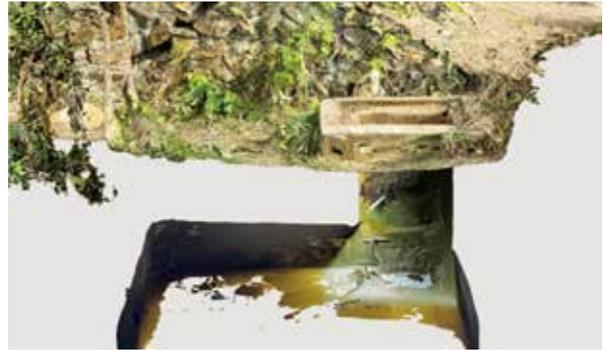
Figure 16

The team managed to empty the cistern using 2 hand pumps on 6 April 2021 in the company of Kenji Kenji Kawase of NIKKEI Hong Kong Bureau (Figure 15). It was found that there is a large rectilinear underground space at the foot of the vertical well (3-D scan image at Figure 16). The volume at the bottom of the access looks something like 1.5m high and about 3m x 3m in plan – a holding capacity for 13,500 litres (nearly 3000 imp. gallons). That meant, if this was a cistern, it could support the full garrison of 200 soldiers for up to 28 days. The narrow, runged-ladder access makes a cistern the most likely use, since for storage, access is simply too restricted.

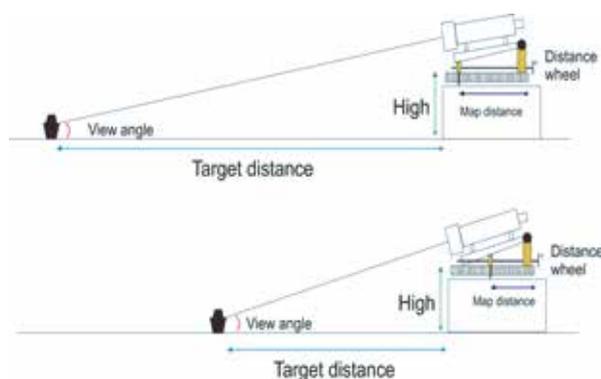
Figure 1: Depression position finder mechanism.

A DPF has a telescope placed on supporting arms, which could tilt down by turning a wheel. Usually two supports connected to the lower mounting that incorporated the slider that was used to read off the range. The target is centred in the cross hairs of the scope's graticule. Range was worked out by multiplying the height of eye by the tangent observed angle. So, the calibrated range/distance scale was an analogue computer read-out that expressed an ANGLE OF DEPRESSION as a DISTANCE TO TARGET. The drawing below shows how a DPF works.

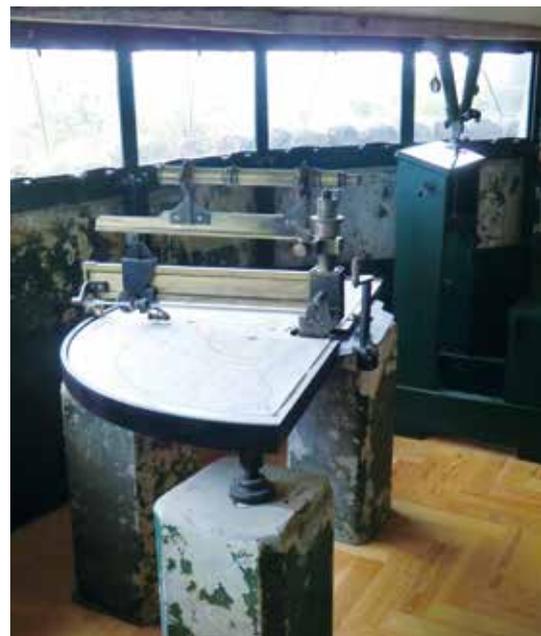
Figure 2: An artillery observation post with a DPF in front and field artillery scope in the back (internet source).

The following sections describe the AOPs on the Hong Kong mainland (**Figure 2**).

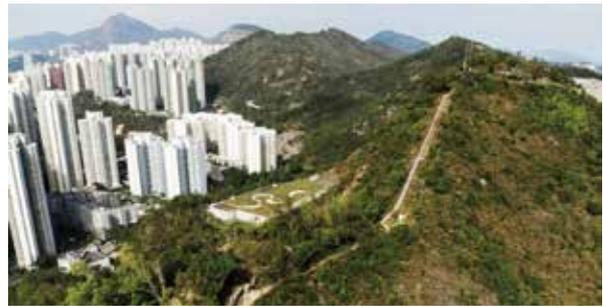
Figure 4: Devil's Peak BOP with the redoubt in the background. The flights of steps were constructed after 2000. A trench lined by well-cut stones was dug along the ridge to connect the OP to the Redoubt (photo by the author in 2018).

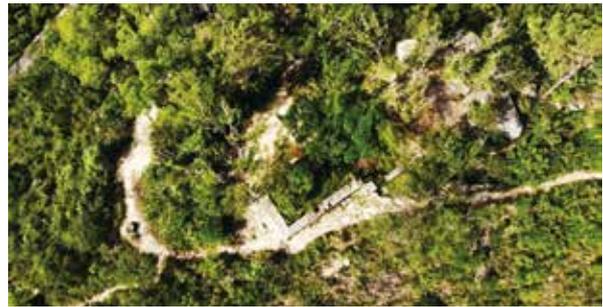
Figure 5: Devil's Peak BOP seen from above. Note the entrance below that connects the trench to the Redoubt (photo by author in 2018).

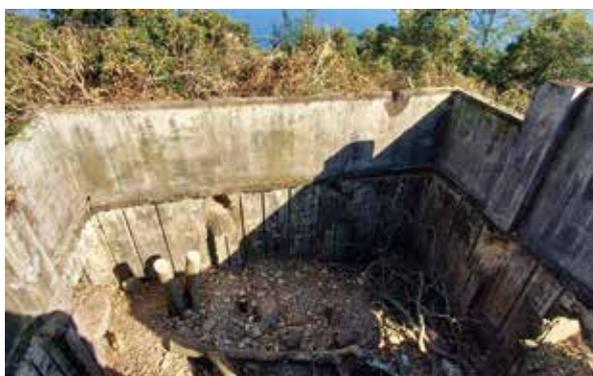
Figure 9: BOP-cum-command center. Note that the roof and upper level floor were demolished (photo by Lawrence W.C. Lai in 2020).

Another BOP-cum-command center, like one found in Mount Davis Fort but subject to better research, was built farther below Gough Battery at about 130 meters. (GPS Position: N22 17 24.6 E114 14 33.0) This was a two-level structure with a BOP and fire control center for Gough and Pottinger Batteries. The roof and floor of its upper level have long been demolished. It has a rectangular extension on the side and a concrete trench connects to the entrance (**Figure 8**). The current condition of this structure is poor and its floor has been covered by earth and thick vegetation. It is very difficult to inspect the site and get a clear view of it. This BOP probably closed when the guns of Gough and Pottinger Batteries were removed (**Figures 9 & 10**).

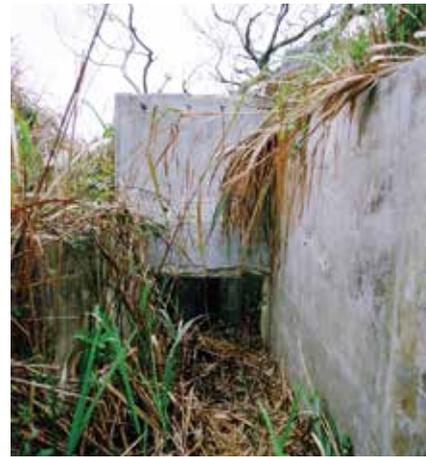
Figure 10: Concrete trench connecting to one of the entrances (photo by author in 2000).

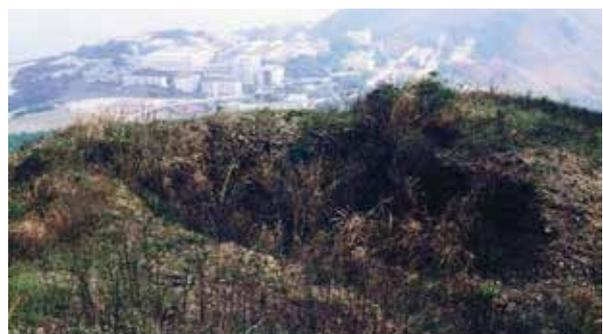
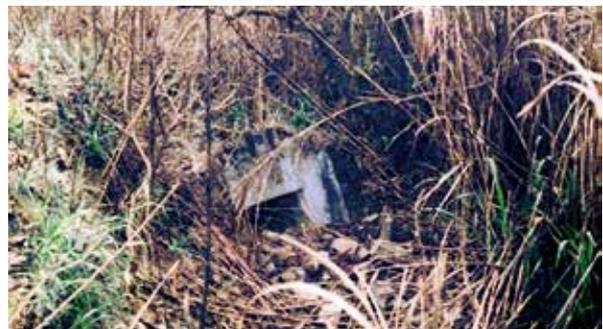
Figure 11: Razor Hill AOP after a hill fire. Note the remains of the concrete structures (photo by Rob Weir, 1990s).

Located at 365 meters along the southern ridge of Razor Hill, this was a formal battery observation post with a concrete shelter that was very similar to that in Shing Mun. The OP was demolished after the war, leaving a big hole on the ground (**Figure 11**). Some concrete structures still remain on the site, but the details of its layout are still unknown.

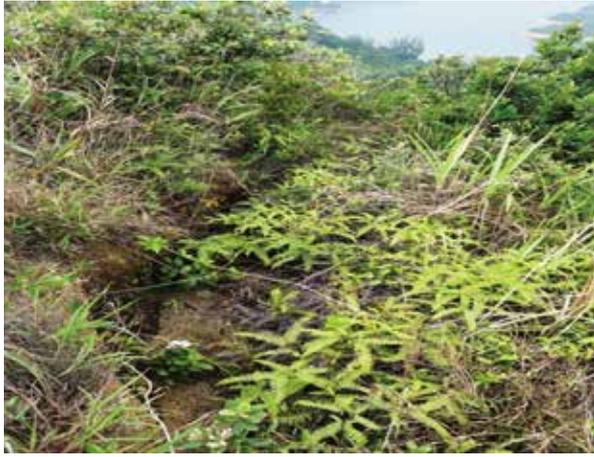
Figure 21: Landslide above the AOP. Note the very steep slope below (photo by author in 2010).

An OP was built above the Shing Mun Redoubt at 310 meters on the northern end of Smuggler’s Ridge. It overlooks the Shing Mun reservoir dam and area below Needle Hill. This AOP was constructed above a cliff on a steep hill slope below the ridge. The 1964 aerial photo (**Figure 18**) shows a landslide above the AOP that was possibly due to the structure’s demolition after the war. The AOP is now a big hole in the ground. Further details of it are unknown and the site is fully covered by vegetation. It is dangerous to inspect this site (**Figures 19-21**).

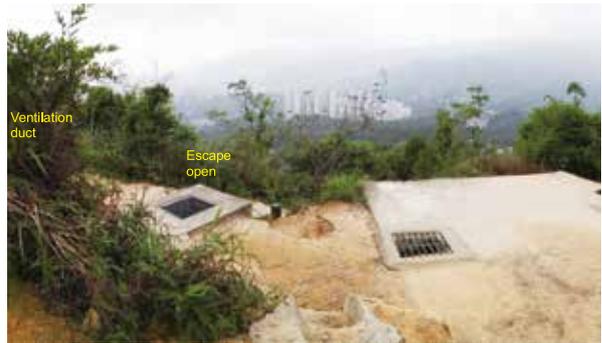
Figure 23: Roof of the Shing Mun AOP. An opening on the AOP's roof was caused by scavengers removing steel reinforced bars from the supporting beam (photo by author in 2014).

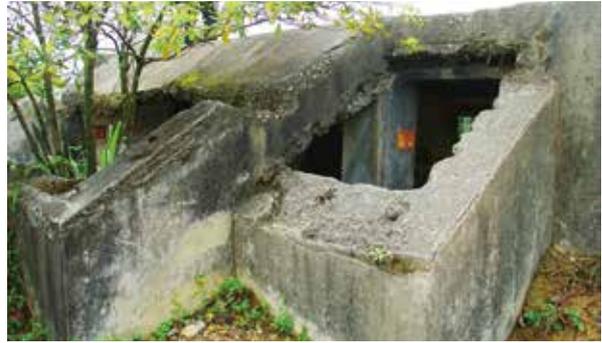
Figure 24: Front of the Shing Mun AOP. The small slit was for a field artillery telescope. The large opening in the back was for the DPF. Both openings had steel shutters for protection. They were removed by scavengers after the war (photo by author in 2007).

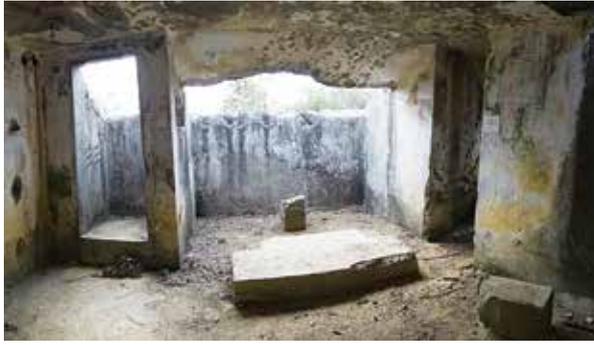
Figure 25: The front of the Shing Mun AOP from the inside. The field artillery scope position was on its left-hand side. The DPF was on its right with a large concrete platform in the back. The three concrete blocks supported the DPF, but two have collapsed and only one remained in its original position. Note the battle damage on the roof and an opening for another field artillery scope position on the right (photo by author in 2014).

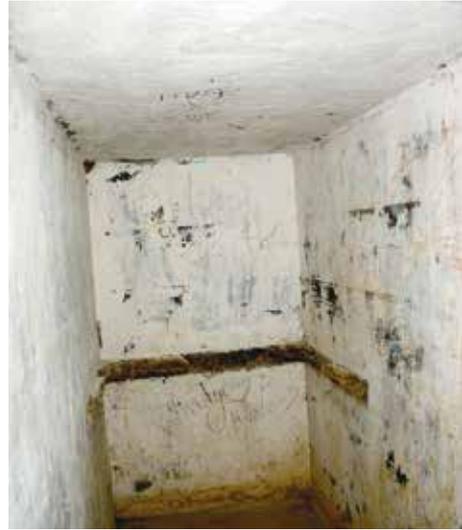
Figure 28: Communication station behind the Shing Mun AOP. Note the missing concrete table (photo by author in 2007).

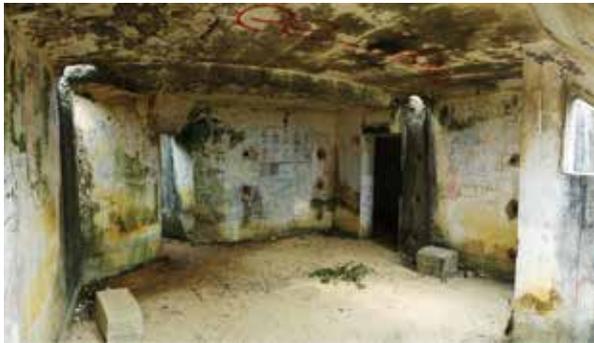
Figure 26: The rear of the Shing Mun AOP. The holes on the wall were for mounting three bunk beds. The openings on the left and middle were for a field artillery scope. The opening on the right led to the communication and living area. Note the support beam on the roof (photo by author in 2014).

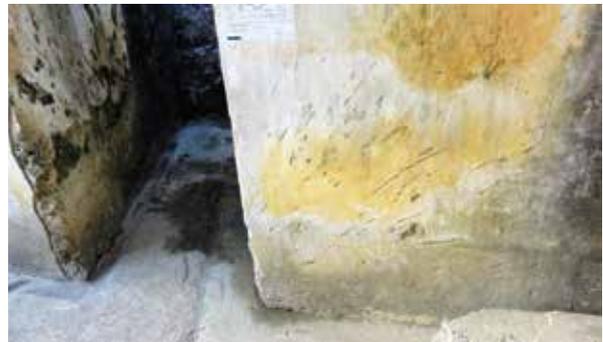
Figure 29: Battle damage on the Shing Mun AOP inside walls caused by Japanese hand grenades dropped from the open observation roof opening (photo by author in 2011).

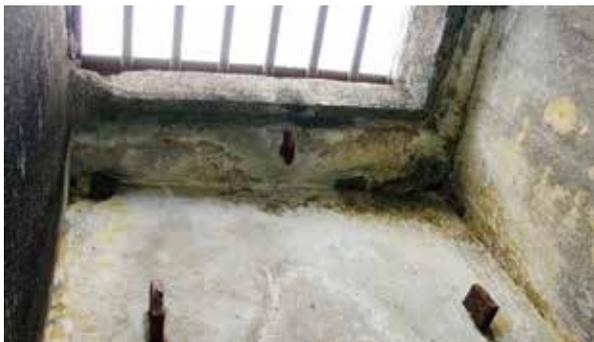
Figure 27: The escape shaft for the Shing Mun AOP. The two metallic remains below were for mounting a ladder. The metallic part on the roof was used to lock the steel exit door (photo by author in 2007).

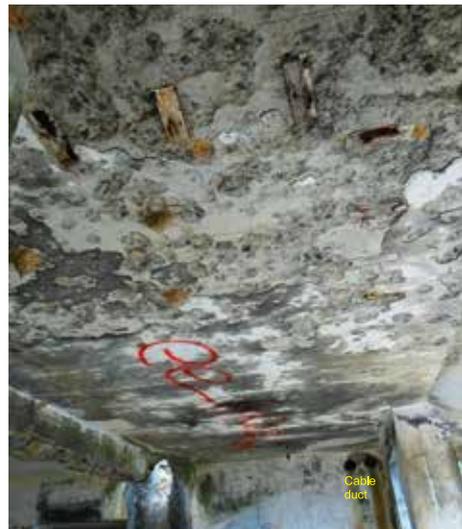
Figure 30: Wooden blocks laid inside the Shing Mun AOP roof used for holding cables to different observation positions via cable ducts. Note the battle damage on the surface of the roof (photo by author in 2015).

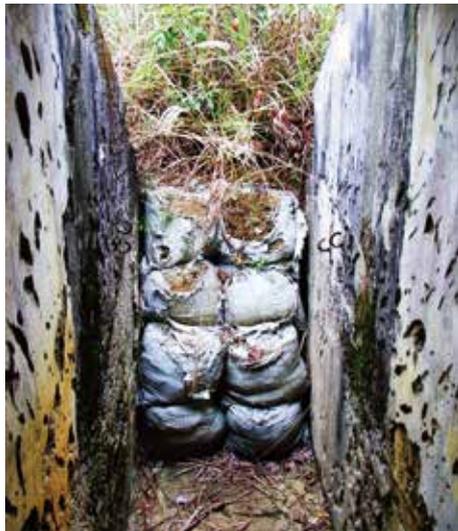
Figure 31: Battle damage to the field artillery scope position inside the Shing Mun AOP caused by Japanese hand grenades (photo by author in 2007).

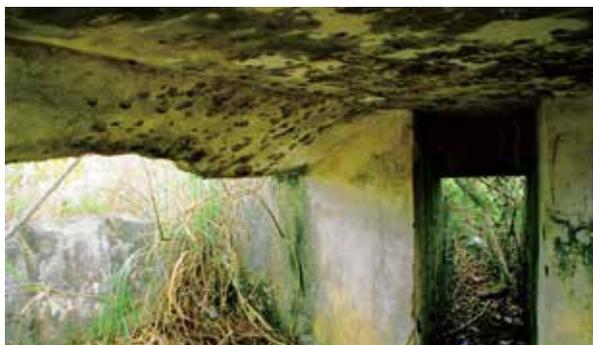
Figure 32: Battle damage to the Shing Mun AOP caused by Japanese hand grenades (photo by author in 1990s).

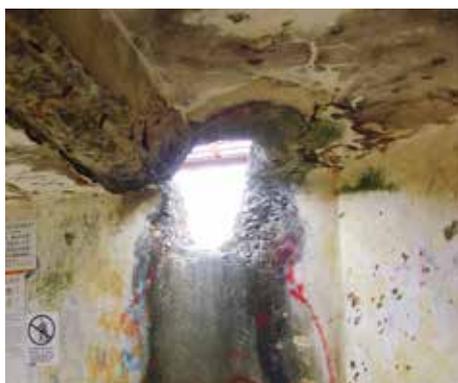
Figure 33: Damage on the Shing Mun AOP roof caused by scavengers removing large steel reinforcement bars below the support beam. The shape of the removed rebars is still visible on the damaged surface (photo by author in 2007).

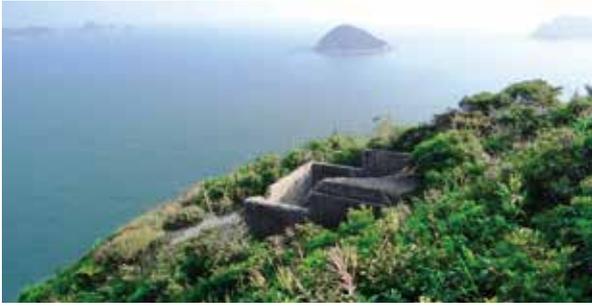
Figure 35: Tai Leng Tung AOP with Steep Island in the background. The roof and upper level floor was demolished after the war to prevent the structure from being occupied by squatters (photo by author in 2016).

Located at 165 meters on the southeastern ridge of Tai Leng Tung, this AOP covered the channels around Basalt Island and the Ninepin Group (Figures 35-43).

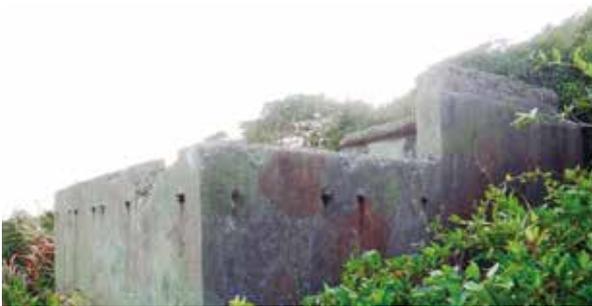
Figure 36: The front of the Tai Leng Tung AOP's upper level. The metal remains on its wall were racks used to hold the steel shutters for the window. Note the remains of the camouflage painted on the wall (photo by author in 2016).

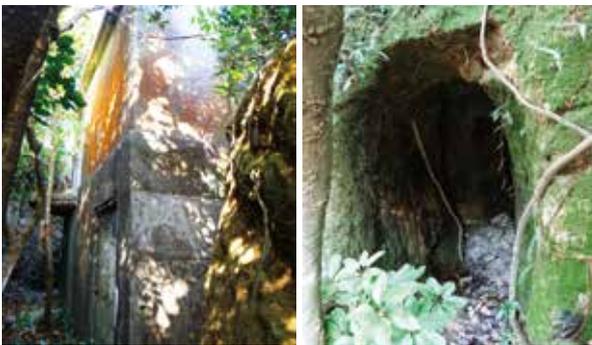
Figure 37: The rear of the Tai Leng Tung AOP entrance hidden inside a large cave. Two trenches on the ground connected to the upper and lower entrances. A steel ladder would have been installed on the platform outside the upper entrance to facilitate access. Note a T-shaped Japanese tunnel dug inside the hill behind the AOP (photo by author in 2016).

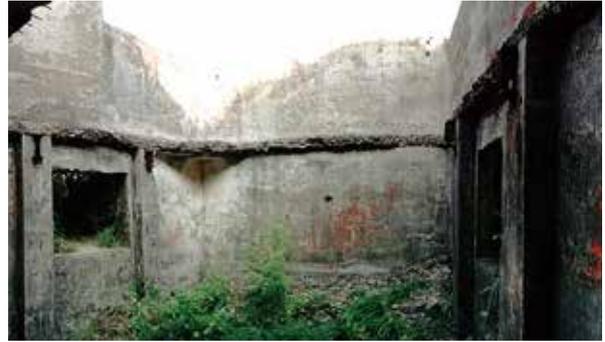
Figure 38: The front of the Tai Leng Tung AOP from the inside. Two large I-beams were used to support the upper level structure. Two windows were on the lower level used for large equipment installation and ventilation. Two trenches connected to these windows separately (photo by author in 2016).

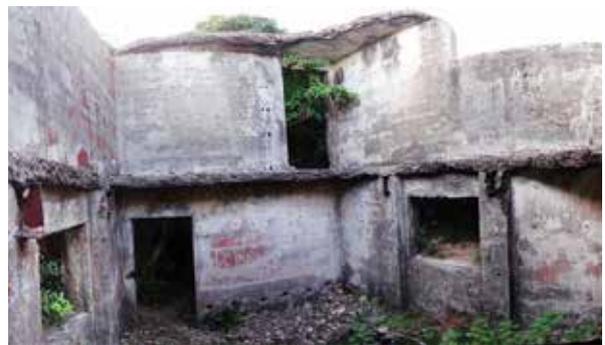
Figure 39: The rear of the Tai Leng Tung AOP from the inside. The entrances to both levels opened on different sides. There is no access from inside the building to either level. Instead, one had to gain access to either floor from outside the AOP (photo by author in 2016).

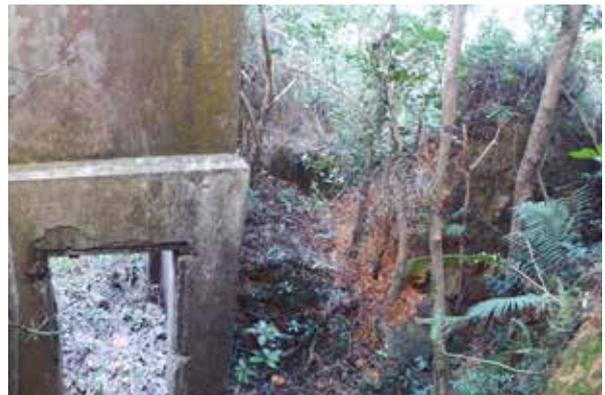
Figure 45: The rear of Ping Tok Hang Shan AOP and its entrance. The deep trench on the right was the main entrance to the AOP. Another trench in the middle connected to the window on the lower level. Note the steep cliff behind the AOP (photo by author in 2016).

This AOP was almost completely covered by vegetation, which makes it very difficult to access today. **Warning:** Many deep trenches and cliffs around the OP are hidden by undergrowth and almost invisible from above. One can easily fall into a trench or hole 4-5 meters deep and find it difficult to get out if one is not already injured (Figures 45-49).

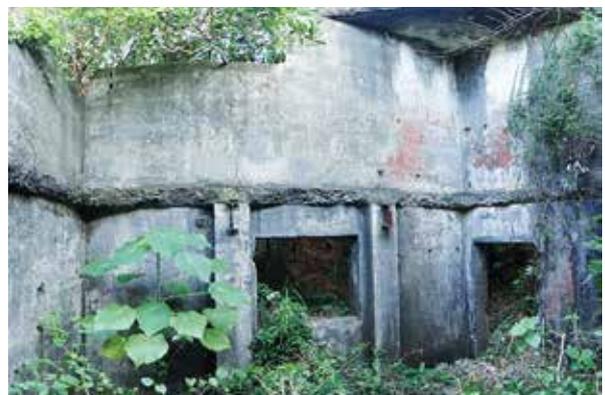
Figure 46: The right interior of the Ping Tok Hang Shan AOP. Its design was the same as that of the Tai Leng Tung AOP. The roof and upper floor of this AOP were demolished after the war (photo by author in 2016).

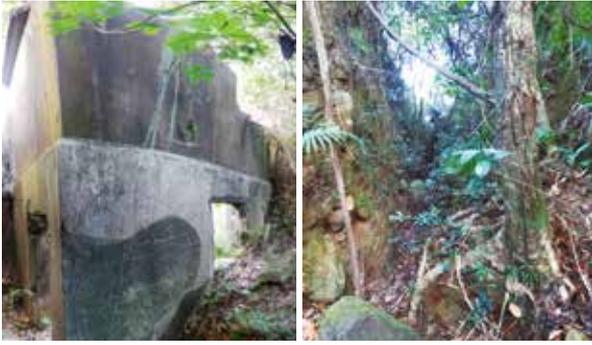
Figure 47: The right side of the Ping Tok Hang Shan AOP with the upper and lower entrances at the rear. The earth outside was piled up to the same level as the lower level window on one side and to the upper level in the front. The right photo shows the narrow and deep main entry trench now blocked by vegetation (photo by author in 2016).

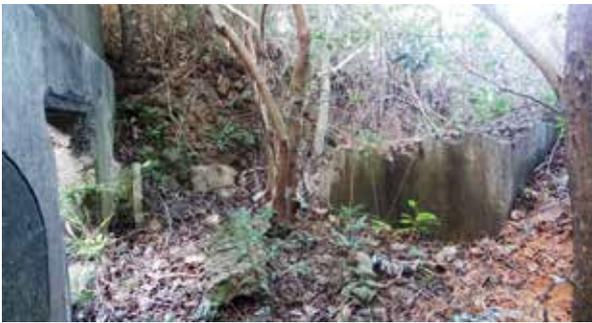
Figure 48: An L-shaped support wall was found outside the right-hand, lower level window. The upper section of the wall was demolished. A trench connected to the lower level window on each side (photo by author in 2016).

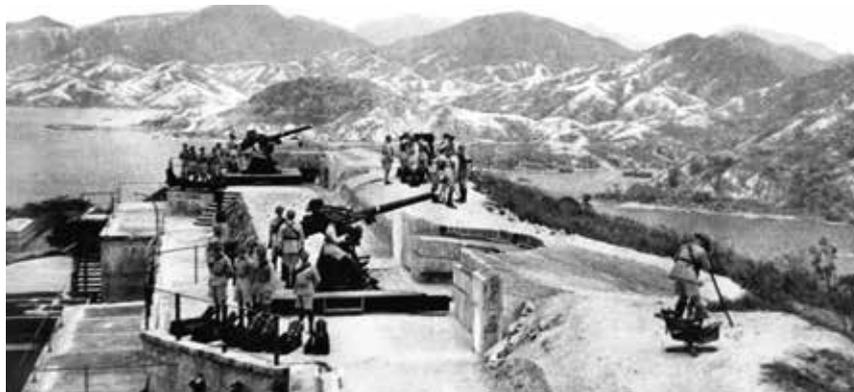
Figure 1: 1939 Sai Wan AA Battery with Two QF Three-inch AA Guns (Photography by RAI).

Hong Kong had four three inch anti-aircraft (AA) guns during the 1920s, but kept all of them in storage. The guns were taken out for training purposes at the end of the 1920s. In 1935, the British realized that Japan would be their future enemy in Asia and started to boost the defences of Hong Kong. In the 1937 air defence layout review, they planned to build 30 searchlight sites and seven heavy AA batteries to protect Hong Kong. (See the layout of the 1937 AA defence plan in the AA searchlight section as a reference.) In January 1938 the War Office recommended that Hong Kong be equipped with 32 3.7 or 4.5-inch AA guns to replace its old three-inch guns. However, due to budget limitations and the threat of war with Germany, there were not enough guns to supply Hong Kong. In July 1938, the Committee of Imperial Defence accepted the policy of defending Hong Kong Island only. All heavy guns on the mainland side, including the AA guns, were moved there. When the war began in December 1941, there were no heavy AA guns on the mainland side. On Hong Kong Island AA batteries were constructed for fixed and mobile guns (Figure 1).

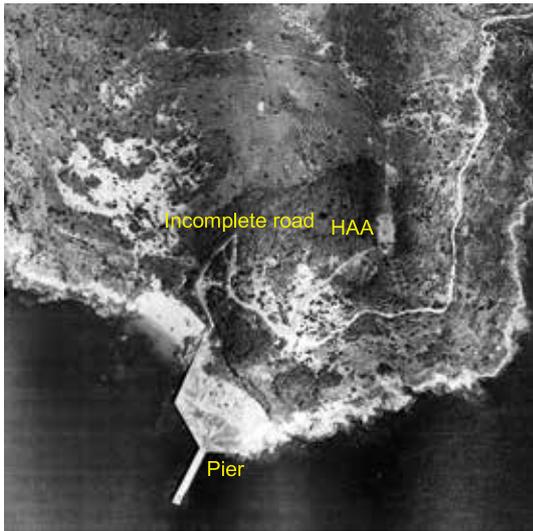
Figure 6: Portion enlargement of R.A.F. 1949 aerial photo 81A_117-6104.

This battery is only shown on the 1937 AA defence layout. It was built on a hilltop in Lai Chi Kok where Kwai Chung Hospital is located today. This site could only be accessed by boat, as no road connected there. A large pier built on the seaside provided access to it and supported the battery's construction. A road laid from the pier to the AA battery was located on the hilltop. The battery occupied a flat space on the hilltop and none of its buildings (Figure 6) have been spotted on postwar aerial photos. It was probably abandoned soon after its construction started in 1938, when the defence policy changed. Thus, it was never completed and nothing remains

of it. Therefore, full details of it are unclear.

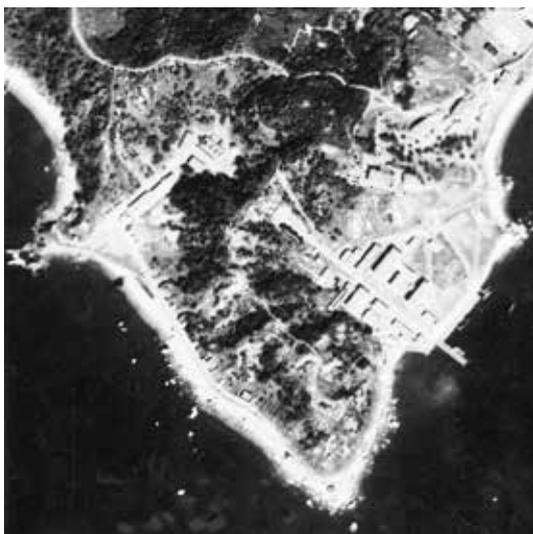
Figure 7: Portion enlargement of R.A.F. 1945 aerial photo 681_5-4156.

This battery was supposedly located at the southeast point (White Point) of Stonecutters Island, but its actual location is unknown. Also unclear are the details of the battery and anything that remains there. The attached aerial photo shows the area around the battery in 1945 (Figure 7).

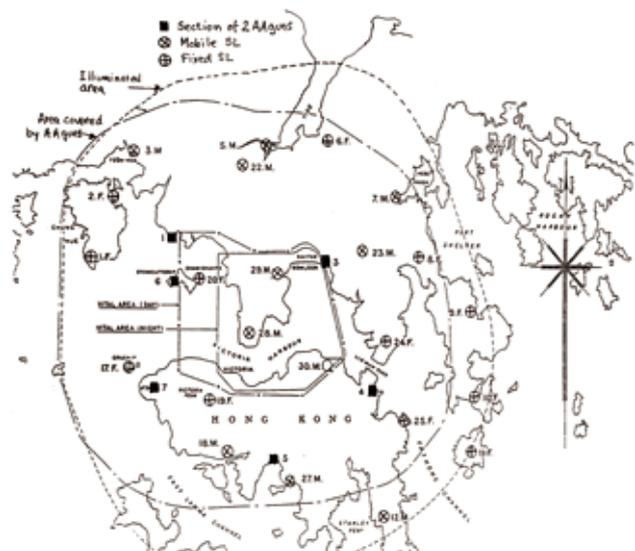
Figure 1: The Anti-Aircraft Gun and Searchlight layout as planned in 1937.

A 1937 anti-aircraft gun and searchlight plan (Figure 1) shows the deployment of 30 searchlights on Hong Kong Island and the mainland to detect enemy aircraft at night. The anti-aircraft batteries surrounded the central city area to provide protection. However, the actual deployment of anti-aircraft guns and searchlights during wartime was a bit different from the plan. More anti-aircraft batteries were allocated to Hong Kong Island and some searchlight sites were placed at better positions.

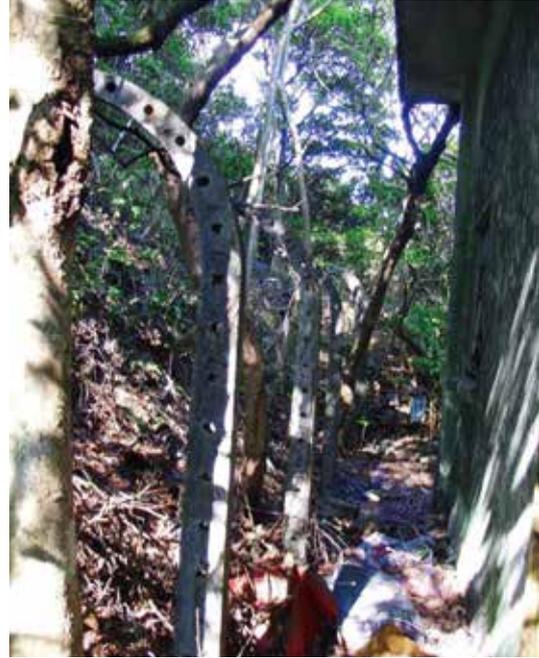
Figure 2: Remains of concrete posts for no evidence perimeter fences at the Mt. Austin AASL site (Demolished, photo by author in 2005).

The searchlight sites were surrounded by barbed wire on concrete posts (Figure 2) or barbed wire fences

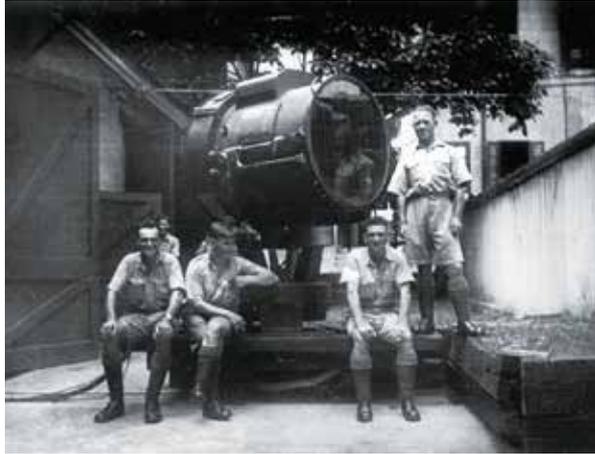
Figure 3: A 1930s photo showing a searchlight (120cm?) in a barracks (Tim Ko's collection).

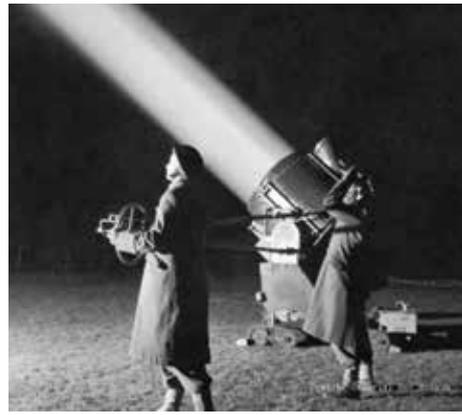
Figure 4: A 90 cm searchlight with tracked wheels in operation during WWII. Note the operator using an extended control arm to maintain distance from the light (Imperial War Museum collection).

The projector (light) was mounted on wheels to allow for easier relocation using manpower. The power requirements for a searchlight were 80 Volts and 250 amps these were supplied by a 24 kW Lister diesel engine. Because of the heat and intense brightness generated by a searchlight, an extended control arm was attached to it to allow its operator to control it from a more comfortable distance.

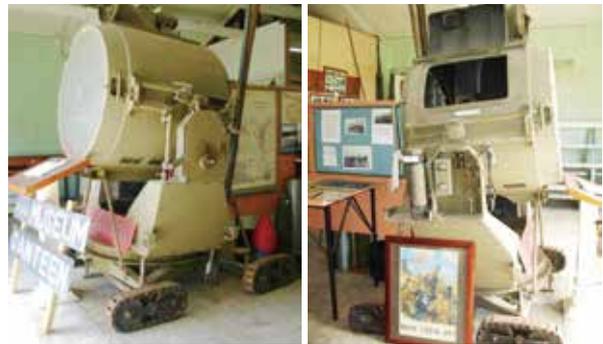
Figure 5: A 90 cm Mk VI searchlight at Brisbane's Fort Lytton. This Australian-made searchlight is similar to the ones used in Hong Kong (Photo by author in 2010).

Hong Kong used British-built carbon arc anti-aircraft searchlights (projectors). Originally 120-cm projectors were used and these were supposed to be replaced by new 90 cm types (Figures 4-7). However, only a few 90-cm projectors arrived in Hong Kong before the war began, so many sites still had to use old 120-cm projectors throughout the war.

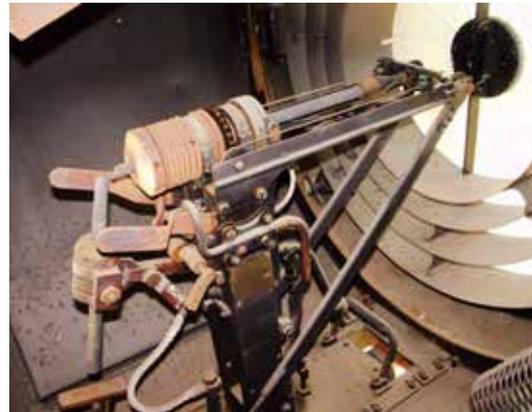
Figure 6: The carbon rods inside the searchlight generated highly luminous electric arcs when the power was on. The rack of horizontal carbon rods can adjust the position between two carbon rods to generate electric arcs, the arc strikes between the tips of the two rods and the 'rack' is the mechanism for moving the movable rod to the fixed rod as its carbon is consumed during operation. (Photo by author in 2010).

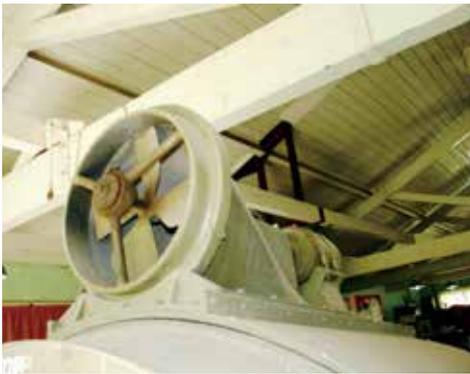
Figure 7: Ventilation fan on top of the searchlight helped dissipate heat and smoke generated by the electric arc (Photo by author in 2010).

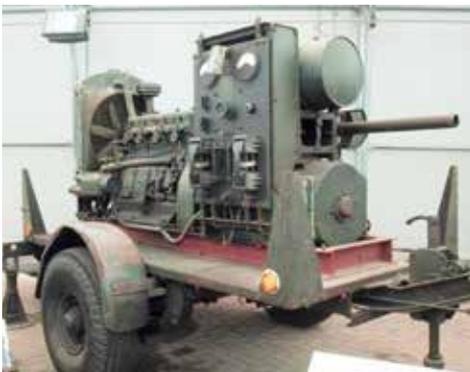
Figure 8: Lister JP4 generator on trailer (internet photo).

A 24 kW, 4 cylinder, Lister diesel engine was used to power the searchlight. The generator was placed on a trailer for mobility or in a concrete shelter for fixed protection. The photo below (Figure 8) shows a Lister generator similar to those used in Hong Kong. The diesel engine is on its left, while a generator with its output controls on the right.

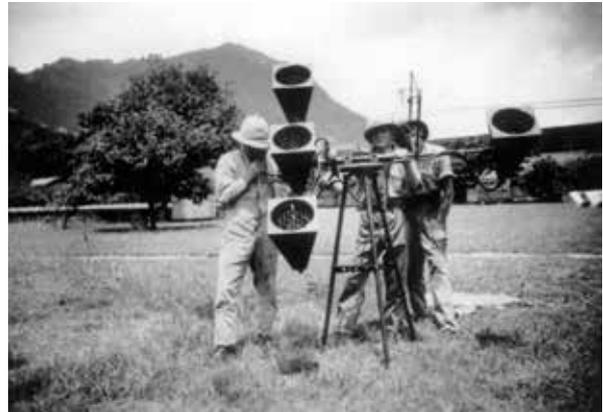
Figure 9: Sound locaters used in Hong Kong during the 1930s (Tim Ko's Collection).

Sound locator. The attached photo (Figure 9) shows a typical sound locator used in Hong Kong before the war.

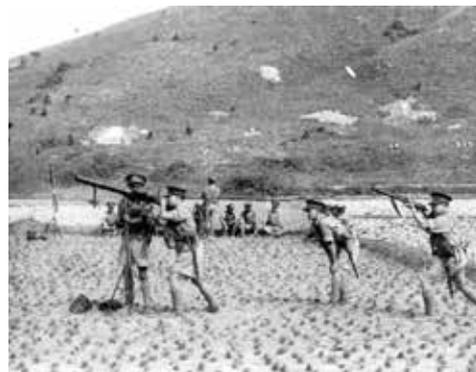
Figure 10: Anti-aircraft company training in Fanling, 1937 (internet photo).

To protect each searchlight site from air attack, a Lewis machinegun post was situated nearby. The machinegun was mounted on a special stand to allow it to fire at a high angle. The machinegun post was normally set in a hole or surrounded by walls to protect the gunner. The photo below (Figure 10) shows a Lewis machinegun in an anti-aircraft exercise before the war.

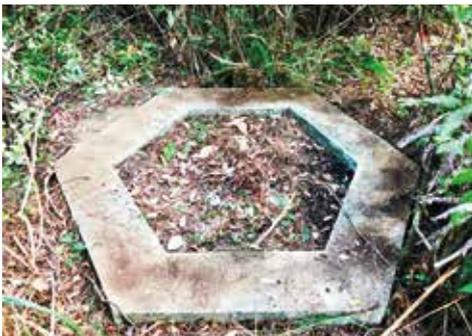
Figure 11: Hexagon-shaped platform at searchlight position at Siu Lek Yuen (Photo by author in 2018).

Small concrete platforms were often found in searchlight positions in remote areas. The platform was hexagon (Figure 11) or octagon-shaped (Figure 12), which made it easier to build.

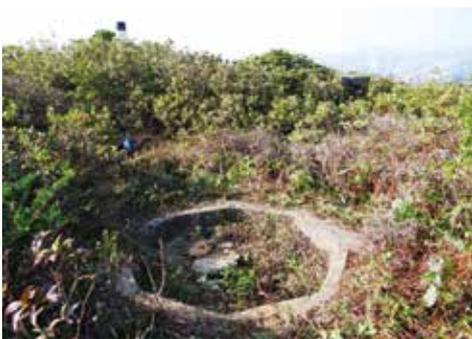
Figure 12: Octagon-shaped platform at searchlight position on Tung Lung Chau. Note the terminal box on the right behind the platform (Photo by author in 2018).

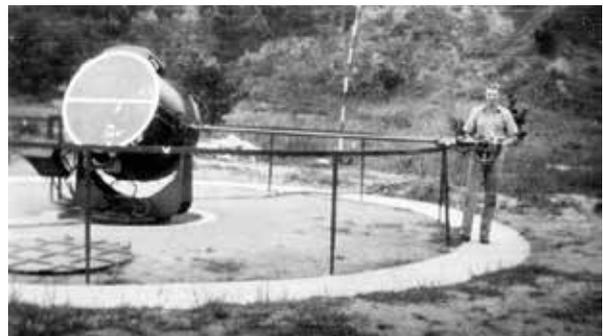
Figure 13: Photo showing a large searchlight position in 1930. Note the direction indicator (W) marked on the rail (Tim Ko's Collection).

photo (Figure 13) shows a large searchlight position surrounded by a railing. It allowed the operator to remotely control the searchlight using an extended arm. A concrete trench connected to the searchlight position and storage room to facilitate moving the light. Note the round plate on the left used to cover the searchlight hole when not in use. This searchlight is possibly a 120 cm type.

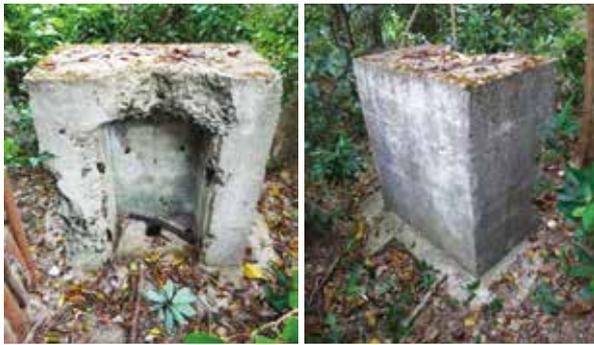
Figure 14: Concrete cable box on Razor Hill (photo by author in 2014).

A concrete box built near the searchlight platform connected communication and power supply cables (Figure 14). The box had a thick steel door in front to cover the cable panel inside. A hole was drilled at the bottom for a cable to go through its underground concrete duct. An operator had to open the door and plug in the power and phone lines to operate the searchlight.

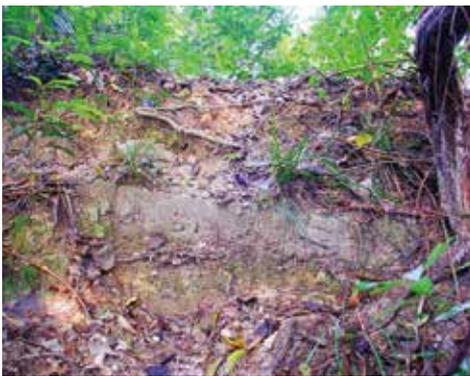
Figure 15: Underground concrete cable duct exposed in Razor Hill (photo by author in 2014).

A heavy twin cable was encased in a concrete duct running from the engine room to the searchlight position. This duct also protected the cables from battle damage. The photo below (Figure 15) shows a concrete cable duct exposed by weathering.

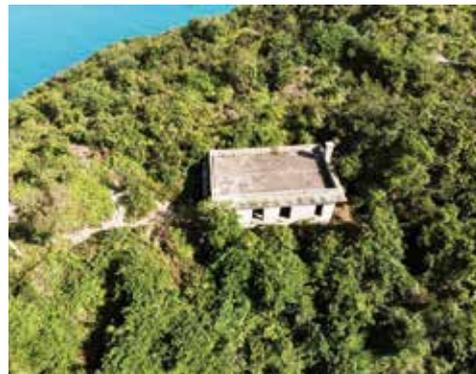
Figure 16: Searchlight equipment storeroom near Cape Collinson (photo by author in 2018).

The equipment storeroom was a concrete shelter built near the searchlight position (Figure 16). It was

normally built at a lower level and hidden by landscaping. The shelter and its windows were fitted with massively strong steel doors and shutters as protection. The personnel entrance was built as a cutout along the hillside to provide protection. A large door on the other side of building faced a flat, open space used for the searchlight and equipment entrance. The building included an office with a direct communications link to headquarters. However, some remote sites had no phone communications line and had to use signal lamps to communicate with other sites that were in visual range.

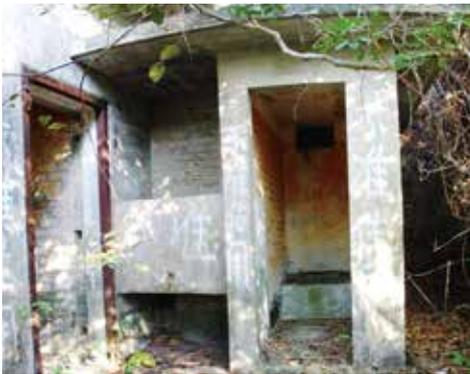
Figure 17: Personnel entrance, water tank, and pit toilet at the back end of the shelter (photo by author in 2005).

The site was not designed as a permanent living quarters and was only manned during operations. It provided basic amenities like a toilet and kitchen (Figures 17-22). The site was normally located in a remote area and all supplies, including water, had to be carried by the crew. The crew had to sleep in tents or on the storeroom floor. During idle periods, the larger equipment was locked up in the shelter, while the smaller items were taken away.

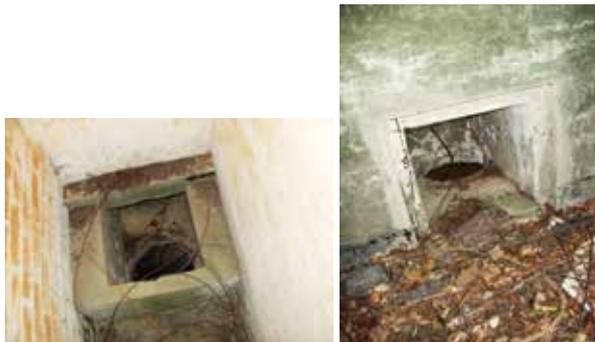
Figure 18: Left photo shows the inside of pit toilet. A toilet seat possibly covered on the hole before. Right photo shows an opening behind the toilet probably used for emptying or cleaning (photo by author in 2005).

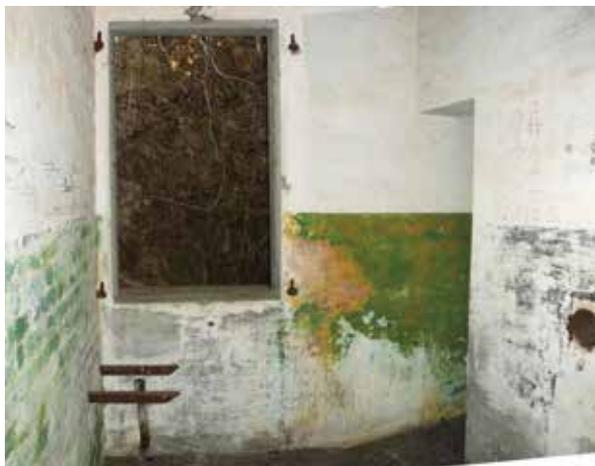
Figure 19: The kitchen with rack and pipe for a basin on the left. The hole in the wall on the right is a chimney for the stove. The opening on the right leads to a storeroom. The window had steel shutters before (photo by author in 2005).

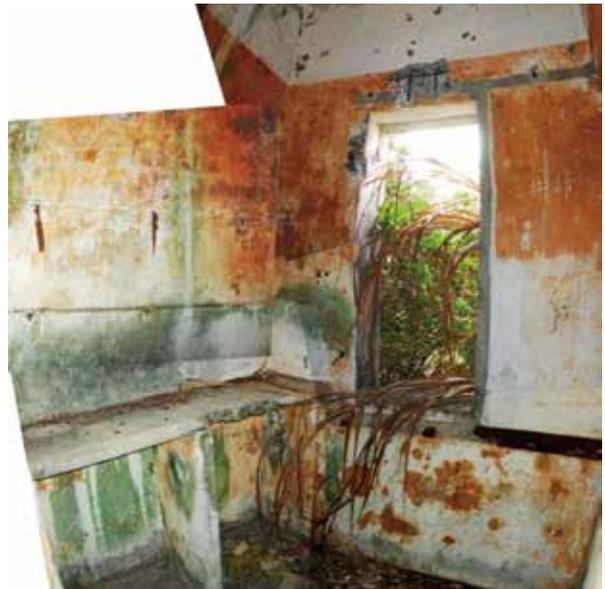
Figure 20: The office with a concrete table and a two-level rack mounted on the wall (both gone). Note the rail on the wall for window's sliding steel shutters (photo by author in 2005).

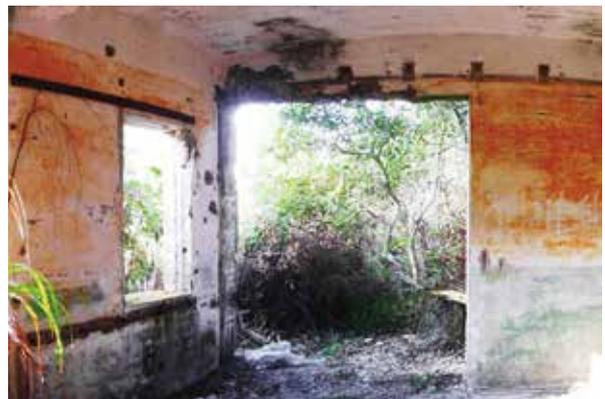
Figure 21: The storage room with large sliding steel door to the open space in the front. Note the wall was painted in different colours different colours at different heights for reasons yet unknown (photo by author in 2005).

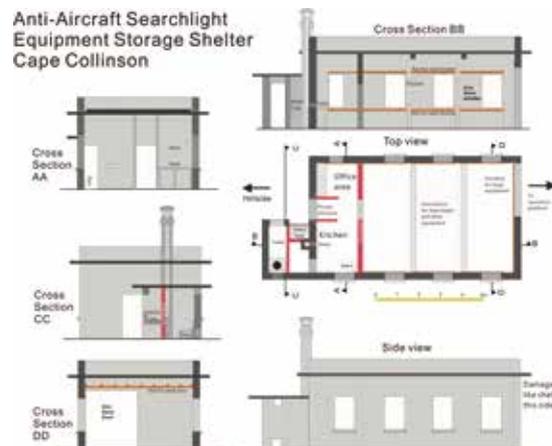
Figure 22: Floor plan of the searchlight equipment storage shelter.

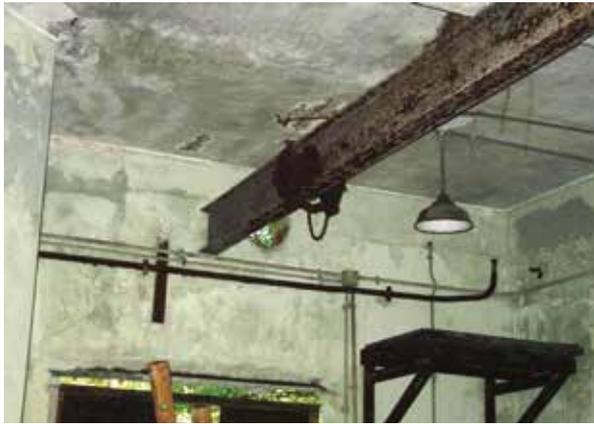
Figure 23: I-beam and crane at the Mt. Austin AASL Site, now demolished (photo by author in 2005).

Such structures also tended to be built along hillsides and were equipped with steel doors and shutters to provide protection. Inside, an i-beam and crane were installed on the ceiling to handle heavy objects (Figures 23-26).

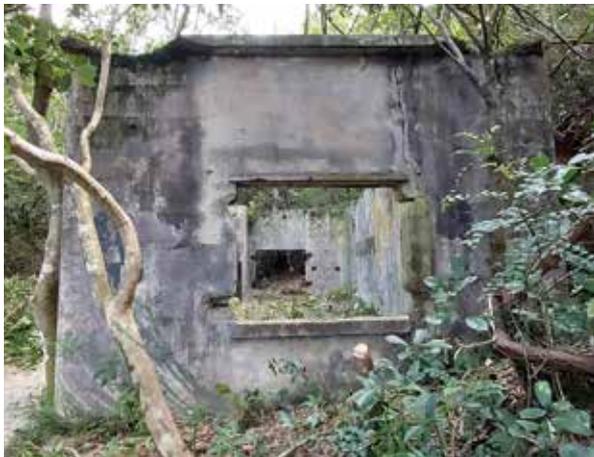
Figure 24: AASL engine room below Devil's Peak Redoubt (photo by Lawrence W.C. Lai in 2021).

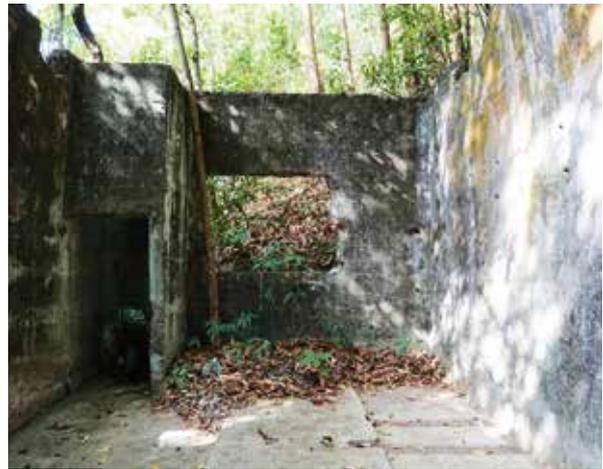
Figure 25: Inside the Razor Hill engine room is the store room and engine platform (photo by author in 2019).

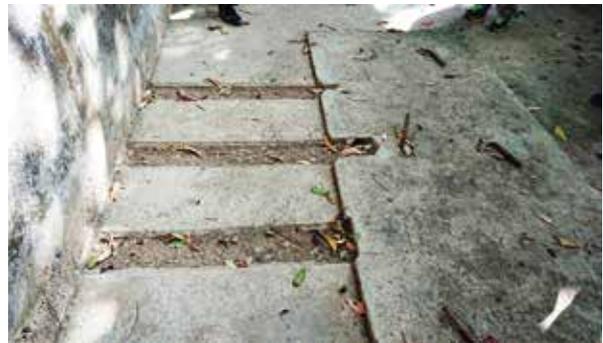
Figure 26: Concrete platform on floor used to install the engine and generator. Three trenches on ground used to place cables from the generator. Note the remains of large bolts used to install the engine (photo by author in 2019).

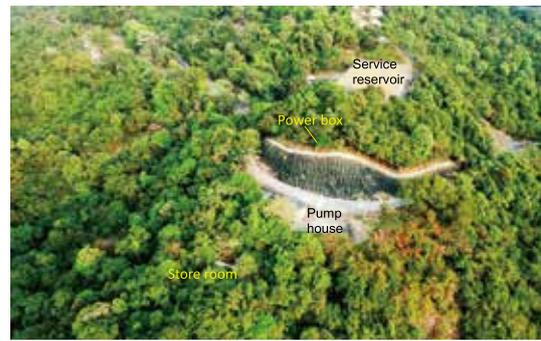
Figure 28: Recent photo of the site (photo by author in 2019).

A fixed site located below Siu Lek Yuen Fresh Water Service Reservoir today. The equipment store room and searchlight position still exist but the engine room has been demolished. The aerial photo below (Figure 27) shows the layout of the site in 1964. Another recent photo (Figure 28) shows the site in 2019 for comparison.

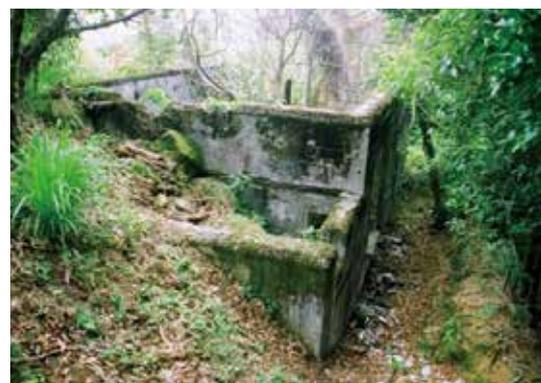
Figure 29: The rear of store room is covered by landfills (photo by author in 2005).

The searchlight store room found below Fa Sam Hang Fresh Water Pump House (See Figure 37). The personnel entrance side is covered by construction land fill. The roof of the building was removed after the war to prevent occupation by squatters. Earth banks on the right side of the photo (Figure 29) provide additional protection to the entrance area.

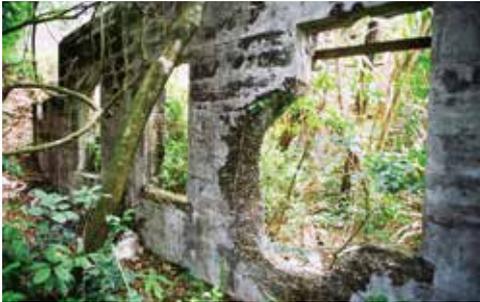
was probably from the same cause. The damage shows the explosion occurred outside the wall at ground level.

Figure 30: The west side wall and large round hole (photo by author in 2005).

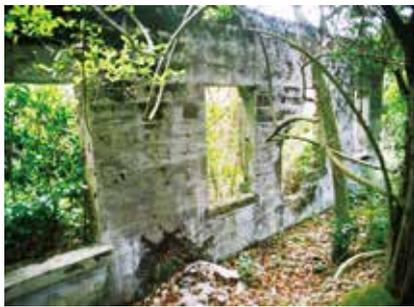
Figure 31: Battle damage on the outside wall (photo by author in 2005).

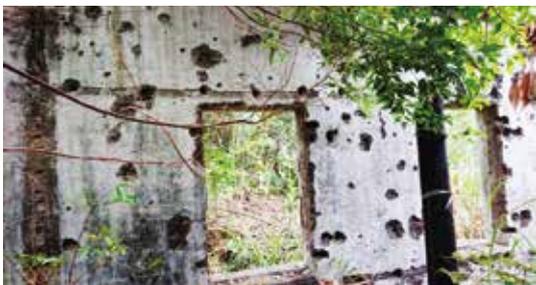
Figure 32: Splinter damage on the inside wall (photo by author in 2019).

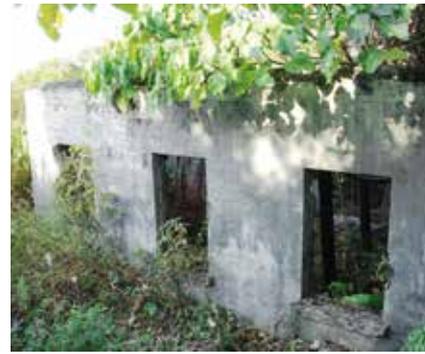
Figure 33: Outside of the east side wall (photo by author in 2005).

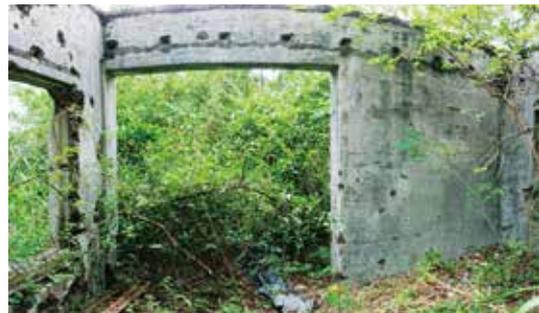
Figure 34: Inside of equipment door area (photo by author in 2019).

Inside of equipment entrance: The horizontal line of damage below the roof was caused by the removal of the rail for the large sliding steel door (Figure 34). All metal parts in the building were removed by scavengers after the war. Note the splinter damage on the wall.

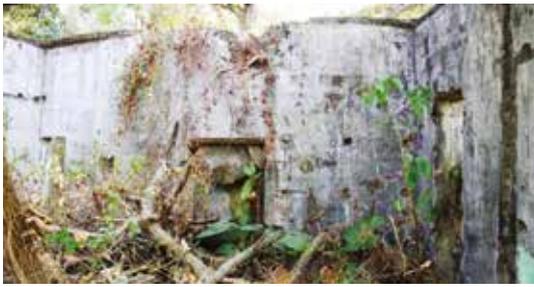
Figure 35: Inside of person entrance (photo by author in 2005).

Inside of personnel entrance: This side was built in a cutout in the hillside to protect people getting in and out (Figure 35). The entrance is now blocked by landfill. On the right side is the office and left side is the kitchen. An opening on the left side connects to the small store room. The vertical damage line on the right is from the removal of the brick wall which separated this area from the equipment storage space.

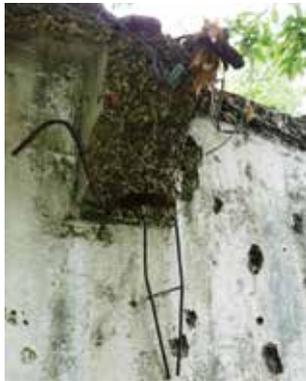
Figure 36: Damaged supporting beam with rebar (photo by author in 2019).

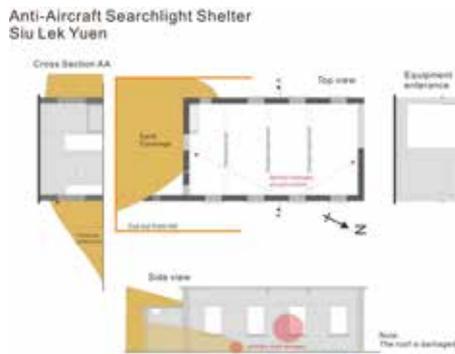
Figure 37: AASL shelter aspect views.

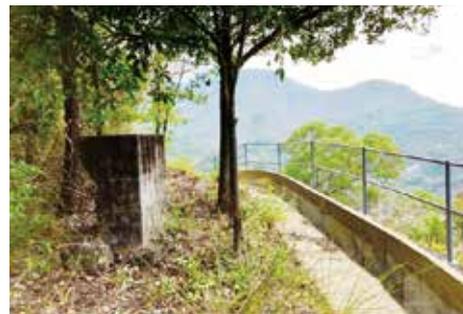
Figure 38: Power box above the cliff (photo by author in 2018).

The searchlight position and power box luckily survived after the development of a road and service reservoir (See Figure 42). The position is above

the road and the power box is just at the edge of a cliff (Figure 38). In the background one can see the ridge of PB 205 which is the edge of Gin Drinkers Line in the Sha Tin area. The searchlight site is far outside the defense line. This site is difficult to defend from attack and would be abandoned on the approach of the enemy.

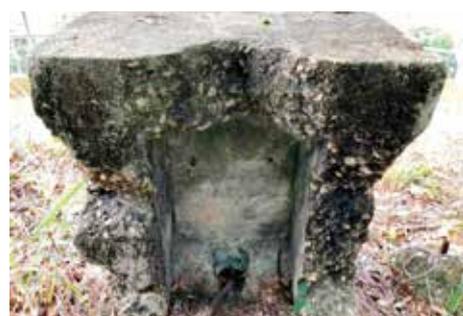
Figure 39: Front of power box (photo by author in 2018).

Front of power box (Figure 39): The panel inside provides a connection to power supply and communication. The hole at the bottom allows cables to go to the cable duct underground. Damage was caused by scavengers removing the steel doors.

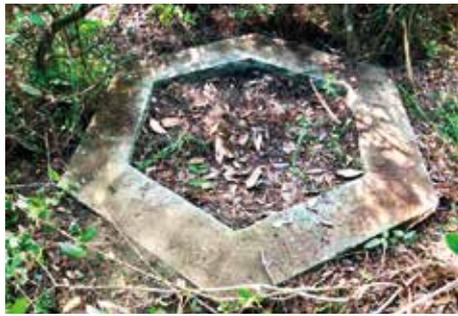
Figure 40: Concrete platform (photo by author in 2018).

A hexagon shape platform (Figure 40) is about six meters away from the power box. The small hole open on the edge was for drainage.

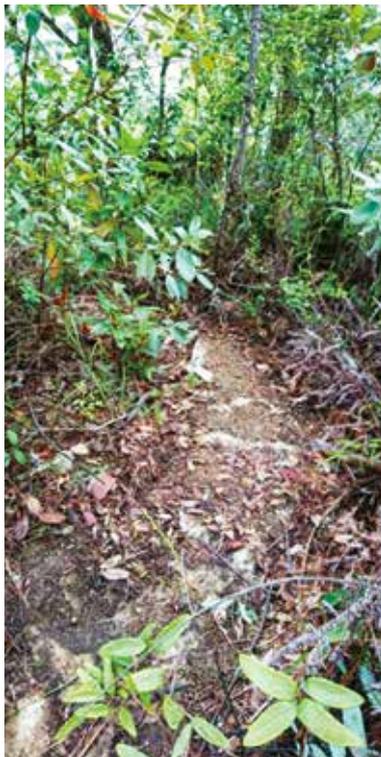
Remains of concrete path connecting the searchlight platform to the power box and store room below (Figure 41). The remaining concrete path is mostly covered by earth and plants. Most of the original path was destroyed by road and service reservoir construction work.

Figure 41: Remains of concrete path to the searchlight post (photo by author in 2018).

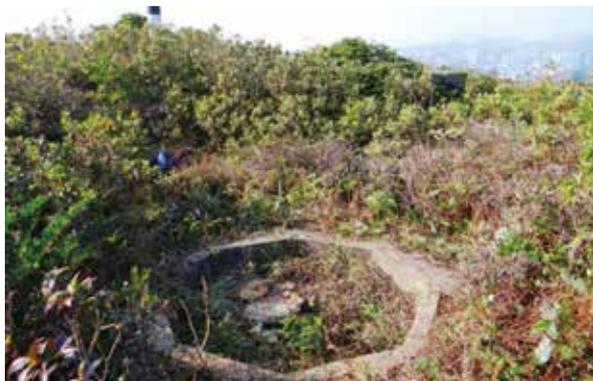
The searchlight position is on the hill top above the store room. The photo below (Figure 49) shows a hexagon shape searchlight position with a power terminal box behind (Figure 50).

Figure 49: Searchlight platform on the hill top with a survey point and Tseung Kwan O behind (photo by author in 2017).
