Surveying & Built Environment

A Special Commemorative Issue Marking the 80th Anniversary of the Battle of Hong Kong

Marking the 80th Anniversary of the Battle of Hong Kong

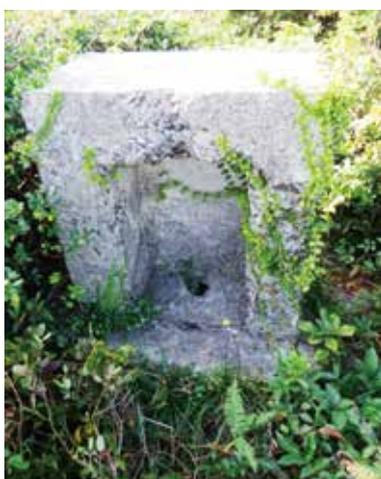
Figure 50: The power terminal box (photo by author in 2017).

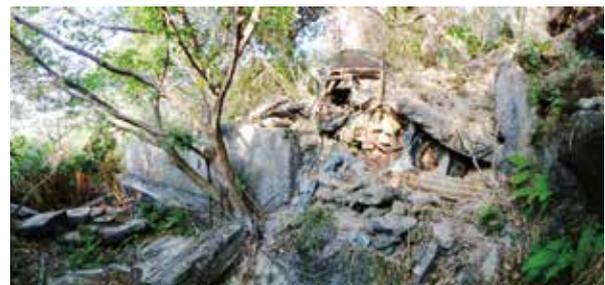
The store and engine room were built together in a valley below the hill. Now the site is fully covered by vegetation. The roof of engine room and store room were removed soon after war. Both structures were further damaged in the 80s (Figures 51 and 52). The walls above the bottom of the window have been demolished. The site has been used as a construction site with a lot of construction waste and equipment. The original path to Nam Tong has also disappeared.

Figure 51: Heavily damaged engine room with a concrete mixer inside (photo by author in 2017).

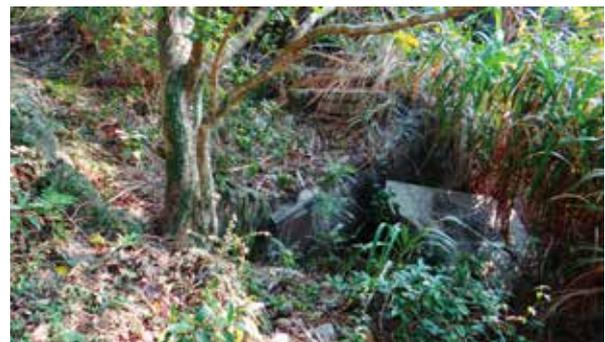
Figure 52: Remains of store room covered by landfill (photo by author in 2017).

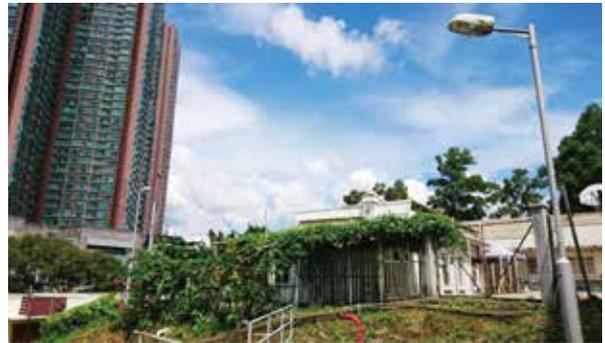
The roofs were removed from almost all searchlight site buildings outside Hong Kong Island soon after the War. This is the only searchlight store room outside Hong Kong Island which still has a roof. This structure was used by a church to help the local fishermen in the 1960s and 70s. Now it is used by Tsing Lam Alliance Church (宣道會青靄堂) (Figure 55).

Figure 55: Searchlight store room on church land today (photo by author in 2019).

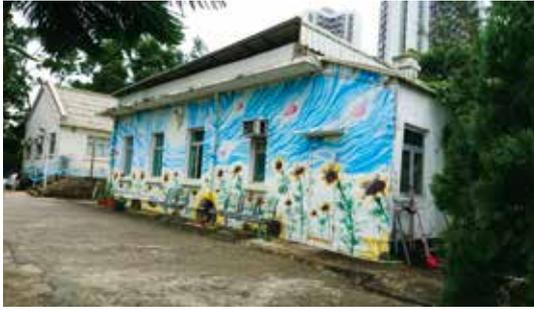
The store room was modified by the church. An additional roof was added on top of original one and the chimney was also blocked. The open area around the personnel entrance is covered with a new window and side door. The inside of building may also have changed. However, this still the most intact searchlight store room outside Hong Kong Island.

Figure 56: Side of store room shows the modified entrance on the right side (photo by author in 2019).

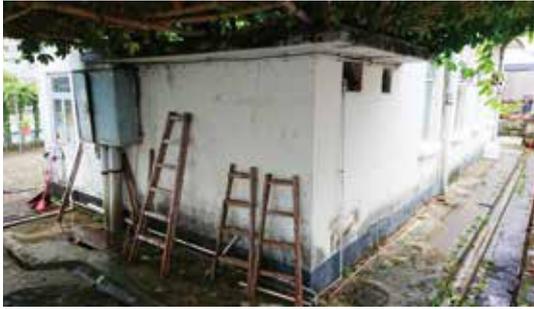
Figure 57: Personnel entrance side of the store room. The extended structure in front was the toilet and water tank. The square mark above the ground now blocked was for access to the toilet. All power and water pipes are modern enhancements (photo by author in 2019).

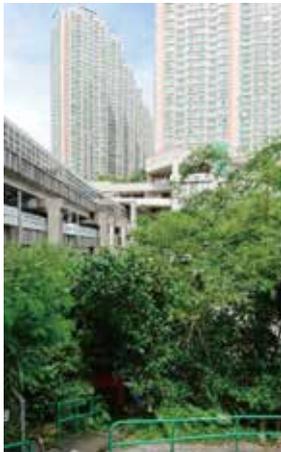
The engine room was demolished but the base still remains. It is located behind the car park under the railway bridge (Figures 58 and 59). The place is used as small temple by the local villagers now.

Figure 58: Remains of engine room base is below the steps in middle (photo by author in 2019).

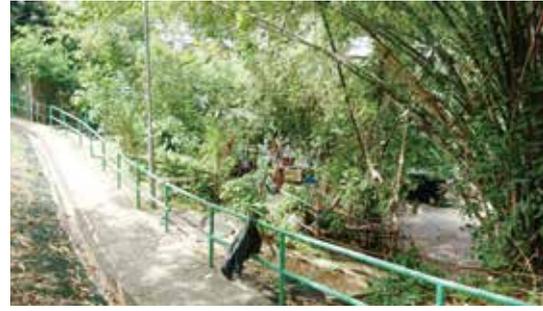
Figure 59: The remaining base of the engine room in the middle. On the Right side is a car park where the water front was located before. The Hill on the left side was cut and reshaped (photo by author in 2019).

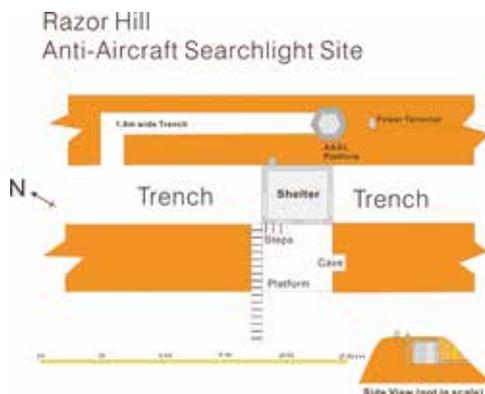
This anti-aircraft searchlight storage shelter is built behind the hill ridge. A platform is in front of the building with steps connected to the engine room below. The searchlight position is on the ridge next to the store room roof. A tunnel portal can be found on the aerial photo (Figure 64) at the end of main trench. It is possibly an air-raid shelter or storage. This tunnel was long demolished. Roads connected to the store room and engine from Clearwater Bay road is clear visible. Also the marker stones at the road junctions can be seen. The marker stone at Clearwater Bay road is gone but the other two stones still exist (Figure 66).

Figure 65: Razor Hill AASL aspect views.

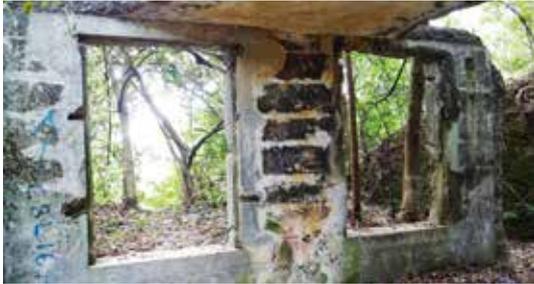
Figure 69: Inside of the front wall and window of the store room. The square hole at the top right is for ventilation (photo by author in 2014).

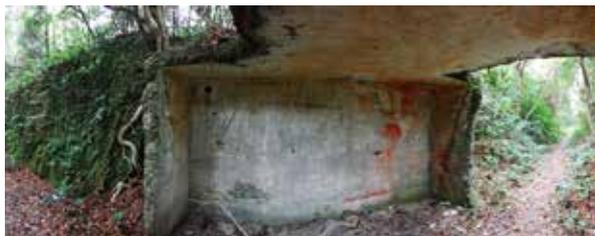
Figure 71: The rear of the store room. The round hole on the top left is possibly a chimney (photo by author in 2014).

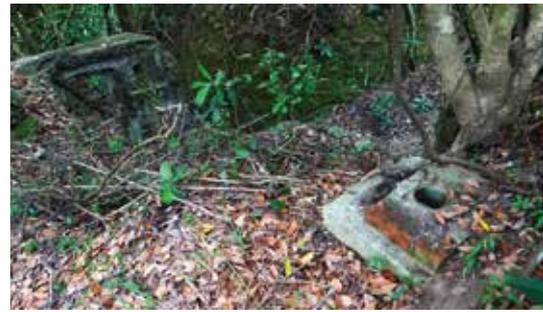
Figure 72: The remains of a chimney hole on the hill top above the store room roof (photo by author in 2014).

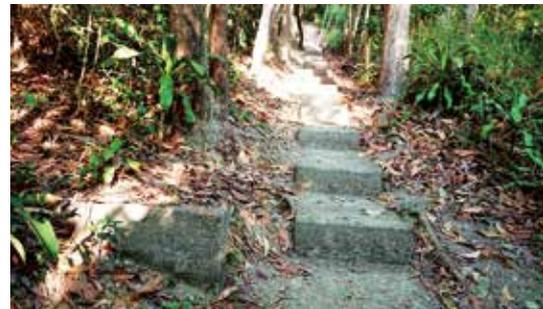
Figure 74: Concrete steps found on the hillside below the store room. They go down to the old path to the engine room. These steps were possibly built by the military to connect the store room and engine room (photo by author in 2019).

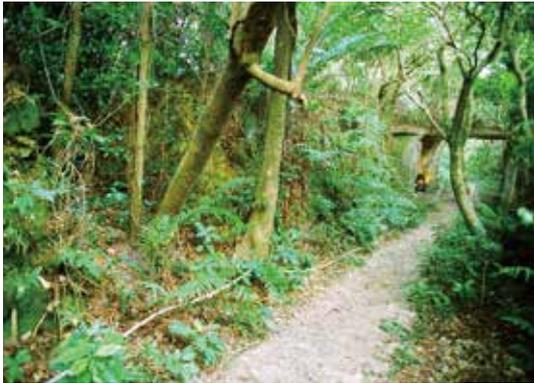
The searchlight is on the ridge next to the store room roof (Figures 75-78). A branch of a 1.8m wide trench connected to the position from the main trench. During operations, the searchlight was moved out from the

Figure 75: Branch of the smaller trench on the left side of the photo connected to the searchlight position (photo by author in 2004).

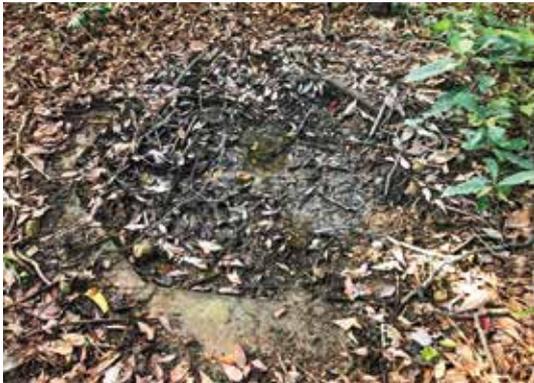
shelter and pushed along the trench to its position by manpower. A hexagon shaped searchlight location and concrete power box can be found near the shelter roof for the searchlight operation. A concrete covered duct was built underground connected to the engine room to protect the power line.

Figure 76: Hexagon shaped searchlight position (photo by author in 2019).

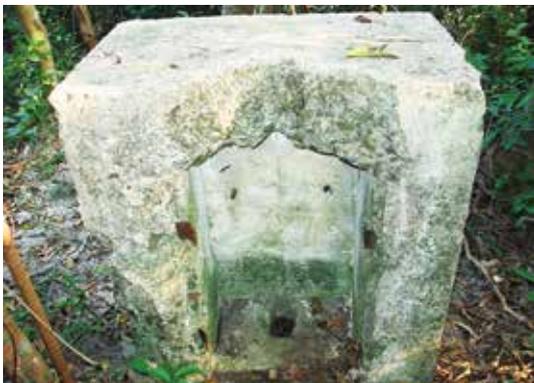
Figure 77: The front of the power terminal box (photo by author in 2004).

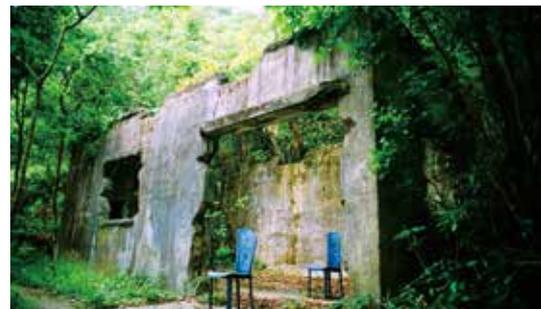
The engine room is on the hillside further below the store room (Figures 79-86). The roof was removed after the war. Most damage was caused by removing metal parts from the concrete.

Figure 79: The front side and large entrance of the engine room (photo by author in 2004).

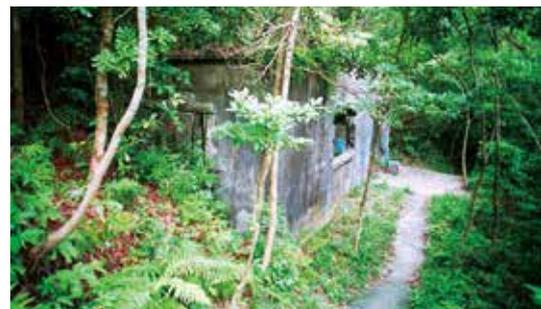
Figure 80: Engine room inside a cutout in the hillside. Note concrete path and the large platform in front of the entrance (photo by author in 2004).

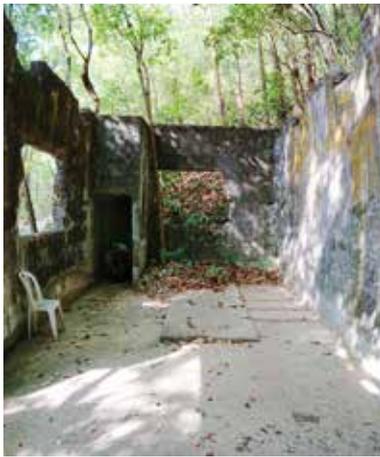
Figure 81: Inside of engine room with the platform for the engine and generator. Damage on top of the wall caused by removal of the roof supporting beams (photo by author in 2019).

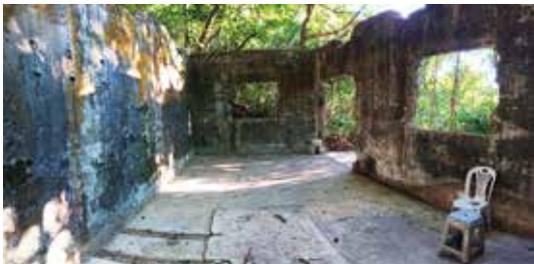
Figure 82: Looking towards the engine room entrance. Note the remains of metal racks on left side wall (photo by author in 2004).

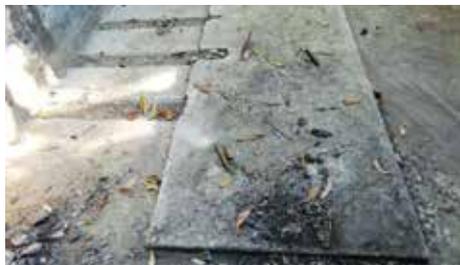
Figure 83: The engine platform and cable ducts. Metal plating originally covered the ducts to protect the power cables below. Note the long bolts used to install the engine on platform (photo by author in 2019).

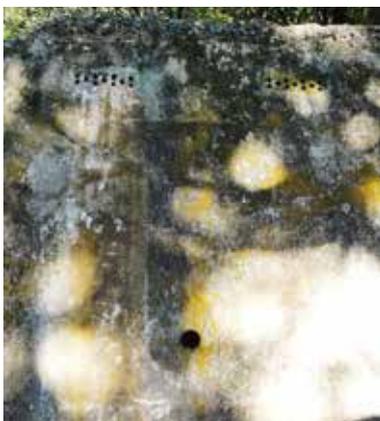
Figure 84: The rear wall inside with open hole for pipeline. Bricks embedded at top of wall have holes for ventilation (photo by author in 2019).

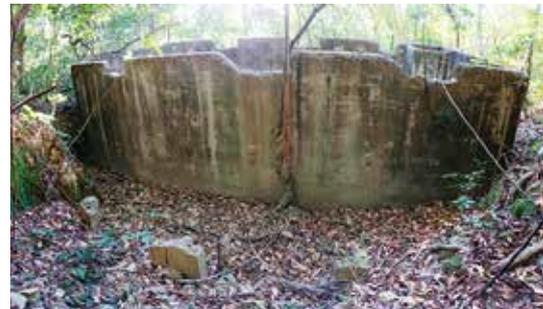
On the rear of the engine room is an extension of a concrete rack that may have been built to support the fuel tank. It is safer to place dangerous fuel outside the engine room. The hole in the wall allows the fuel pipe to connect to the engine inside the engine room.

Figure 85: Rear of the engine room with concrete rack inside a large cutout from hillside (photo by author in 2019).

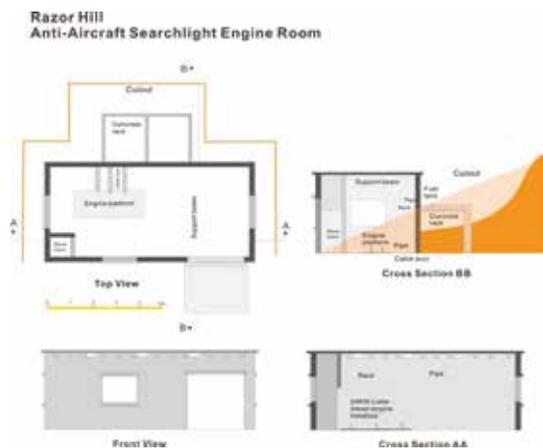
Figure 86: Different aspect views of the AASL Engine Room.

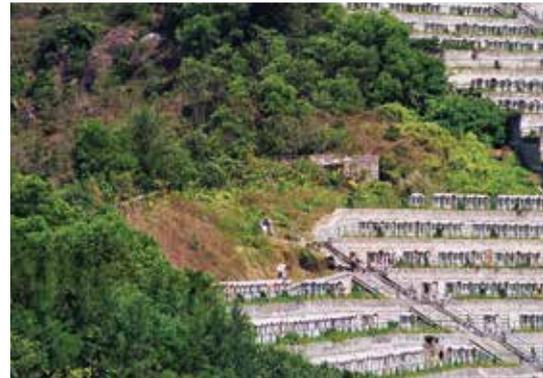
Figure 98: Searchlight store room next to the cemetery (photo by Ping Yung in 2002).

The store room is located on the ridge next to a cemetery (Figures 98-102). Other than missing the roof and metal parts the structure is still in relatively good condition.

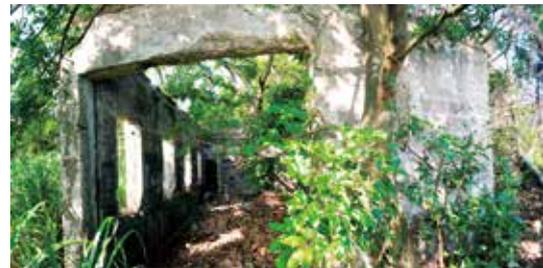
Figure 99: Equipment entrance of store room (photo by author in 2019).

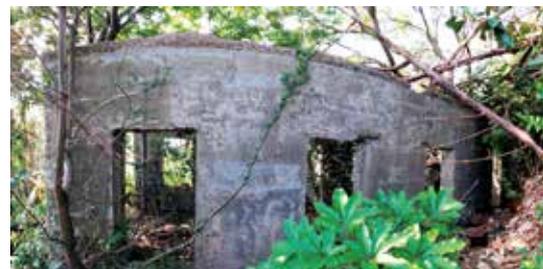
Figure 100: Outside wall of store room. The personnel entrance is on the right side hidden in a cutout (photo by author in 2019).

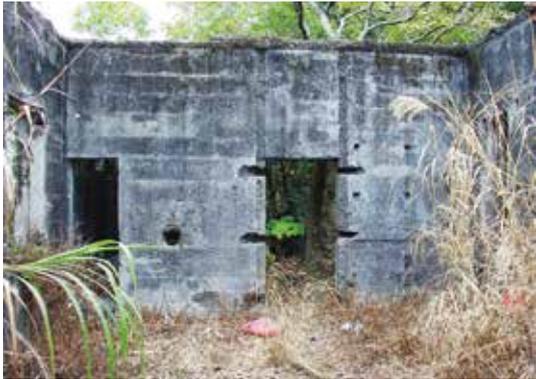
Figure 103: Inside of personnel entrance. Note the door outside is covered by a cliff face (photo by author in 2005).

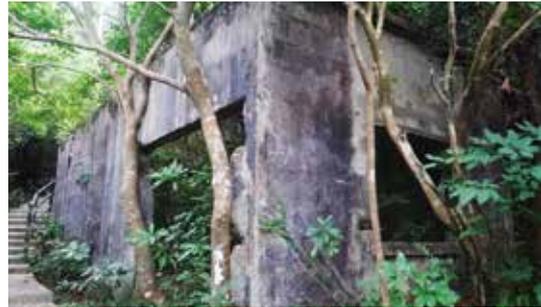
Figure 106: Front of the engine room. The path in front was built in recent years (photo by author in 2017).

The engine room is located in a valley further below the searchlight site.

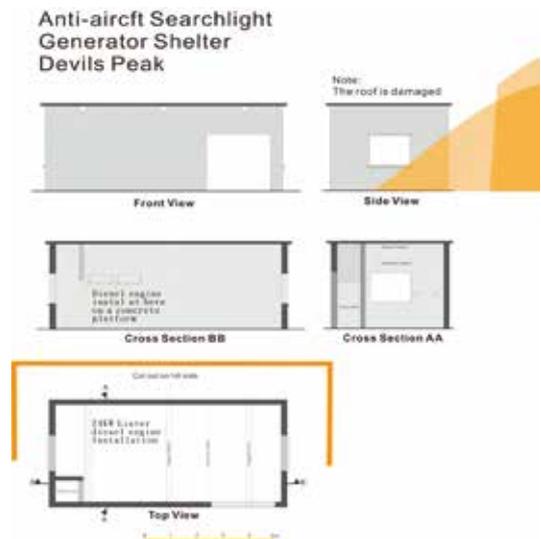
Figure 108: Different aspect views of the AASL generator shelter.

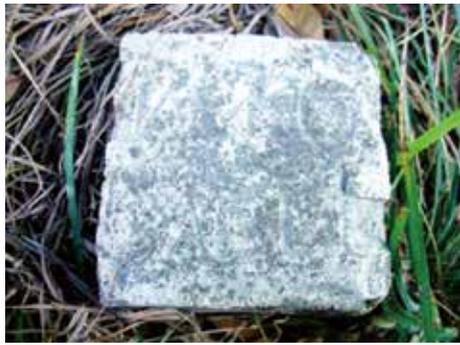
Figure 2: WD cable marker stone on Shatin Pass Road showing the military communication cable below (photo by author, 2009).

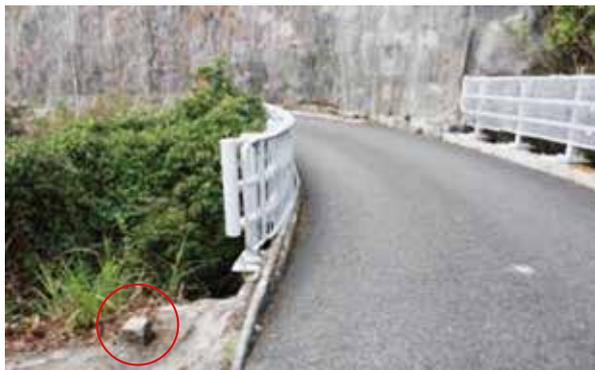
Figure 3: WD cable marker stone on Shatin Pass Road (photo by author, 2014).

Each HQ mainly used telephones to communicate with others, but larger HQs also had teleprinters to transmit text messages. To protect their vital communication lines from battle damage, the defenders placed all communication lines inside cable ducts and buried them underground. This required the construction of a long cable duct network along the entire defence line to link the HQs to the frontline positions. Police stations were used as a communication center in the New Territories before the war because very few other places in New Territories had telephones back then. However, the police station was too exposed to enemy artillery fire, which made it useless during wartime.

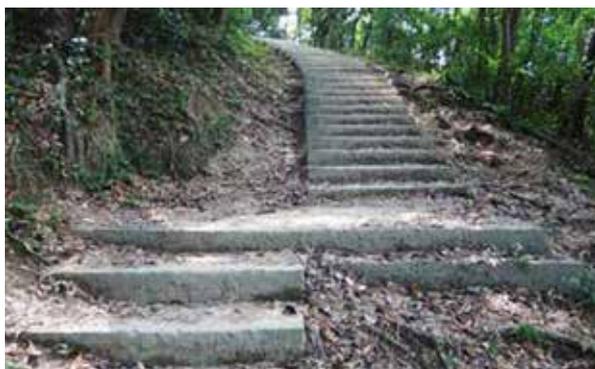
Figure 4: Concrete steps to the Shing Mun redoubt (photo by author, 2015).

Tracks for mule and wheeled transport were built around a HQ for transporting men and materiel from remote locations. A typical track was approximately one meter wide and lacking concrete cover, which meant it had difficulty being an all-weather road. Some HQs, like Shing Mun, had concrete steps to connect to the nearest roads. Zig zag tracks commonly built on slopes allowed wheeled transport or laden mules to navigate steep hills.

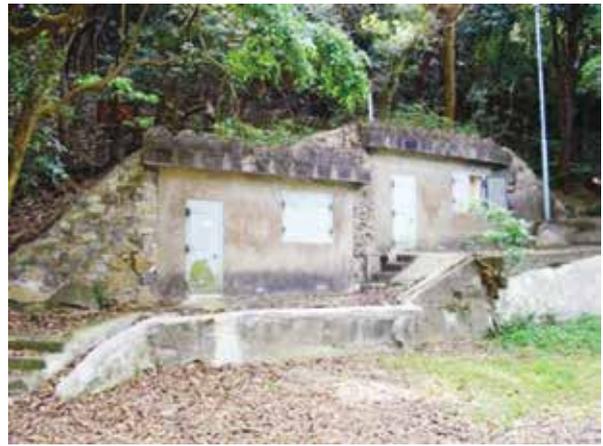
Figure 8: Type A shrapnel-proof shelter in Wong Nai Chung Gap (photo by author, 2007).

A shelter is typically built on a hillside with three sides covered. Its roof was covered with earth to prevent it from being spotted by air and to provide additional protection. Shelters were built individually with at least one foot of space between each other to ensure that damage to one shelter would not affect the others nearby. Each HQ normally had four shelters used as accommodation.

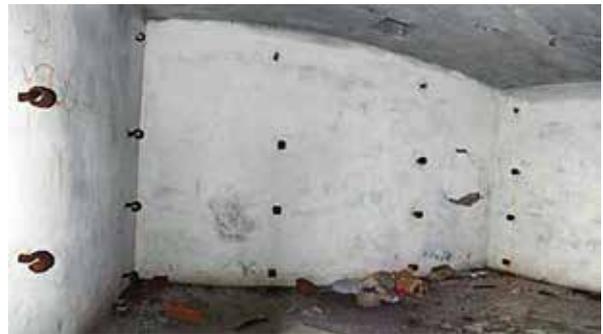
Figure 9: Inside a shelter. The metal rings on the wall were used to mount foldable beds. Three bunk beds were mounted on each wall in this shelter. Note the square-shaped ventilation hole on the roof (photo by author, 2016).

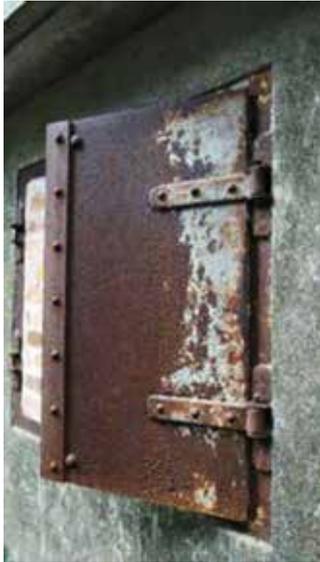
Figure 11: The steel cover for the window (photo by author, 2016).

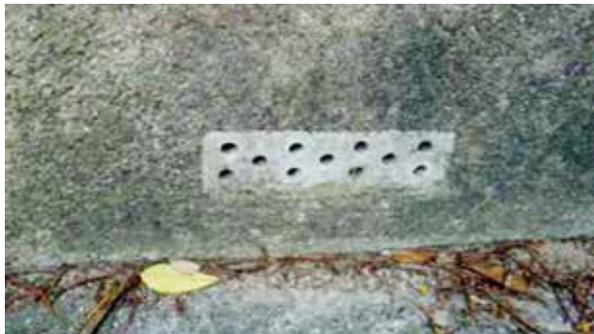
Figure 12: Ventilation holes along the front wall of the shelter (photo by author, 2007).

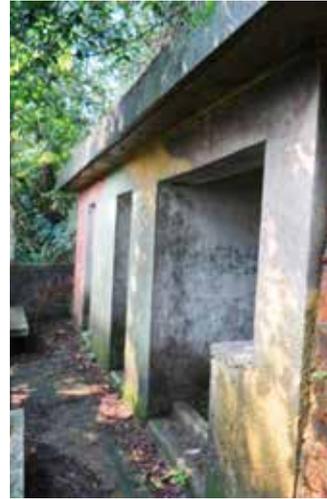
Figure 13: An early military toilet at Pinewood Battery. The wash stand is in front and the two toilet rooms are in the back. Note the camouflage painted on its wall (photo by author, 2000s).

Just like a shelter, a toilet was built along a hillside. It provided some protection for its occupant. Each toilet surveyed by the author had two rooms and each room had two stalls. There was also a separate room with a wash stand.

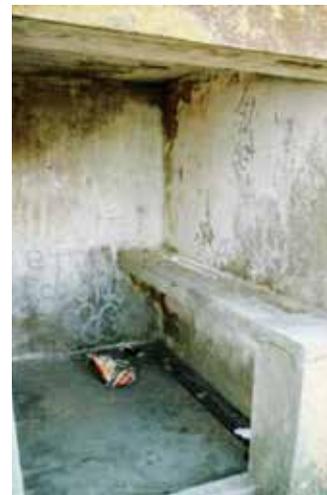
Figure 14: The wash stand (photo by author, 2000s).

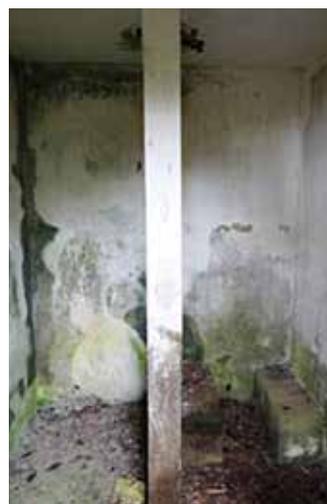
Figure 15: A wall dividing a toilet room into two stalls – one with a concrete stand and one without. Such a design might have been to divide users' lavatory activities. Note the lack of an open hole in the ground, as all solid waste was stored in "honey buckets" and disposed of elsewhere every day (photo by author, 2000s).

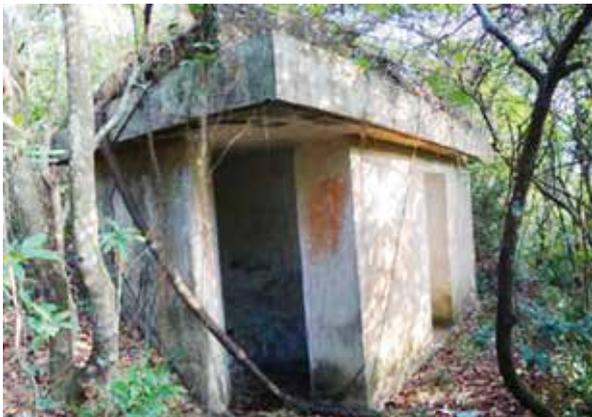
Figure 17: A pit toilet at the Tai Tam Gauge Basin Battery. The officer's toilet is in front. Note the thickness of its shelter wall (photo by author, 2015).

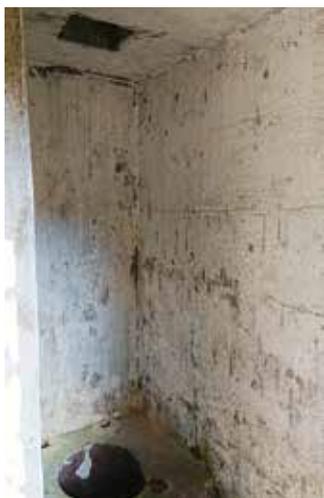
Figure 18: The "executive toilet". Note the toilet seat inside and ventilation hole on the roof. A wooden plate served as a toilet seat on top of a concrete step. A hole on the wall was possibly used as a toilet paper mount (photo by author, 2019).

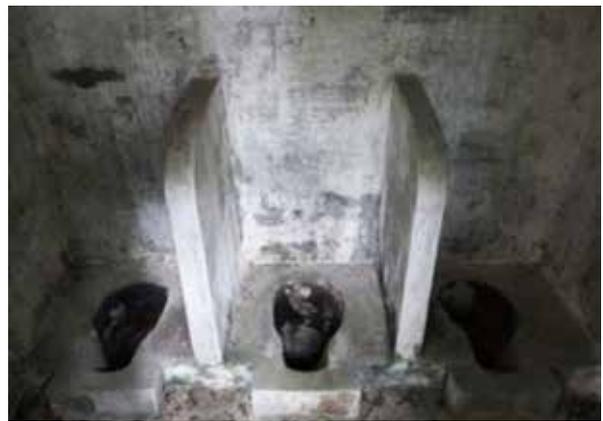
Figure 19: The "common toilet" with three squat pans separated by two short walls. Two ventilation holes on the roof maintained airflow (photo by author, 2015).

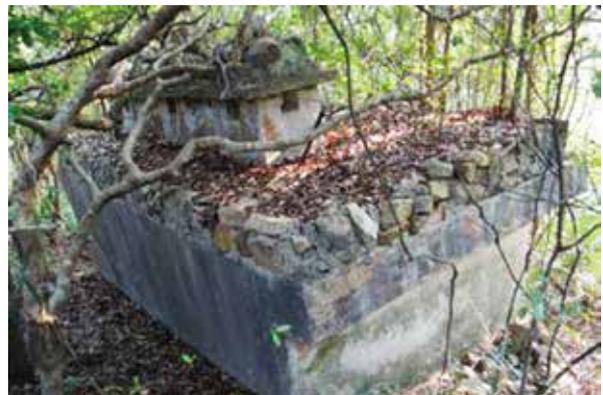
Figure 20: Roof of the toilet shelter camouflaged by rocks and earth. Three ventilation shafts on top typified pit toilet shelters (photo by author, 2015).

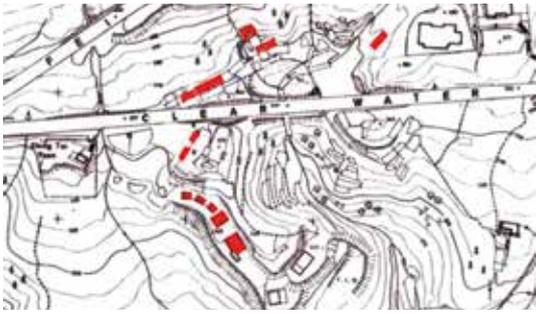
Figure 23: Shelters of the Bn HQ highlighted on a 1968 map (1968 1:1200 survey map C-163-SE-D).

This site (**Figure 23**) was demolished when constructing the New Clear Water Bay Road. However, a shelter still remains there near Sienna Garden. Its remains are mostly covered and only its top section can be seen (**Figures 24 and 25**).

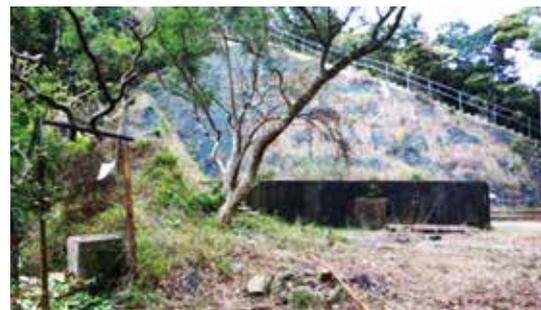
Figure 32: The marker stone and water tank still exist at Shatin Pass (photo by author in 2014).

All HQ shelters and buildings at Shatin Pass, including the old police station, were demolished after the war. Only the cutout for a building on the hillside and water tank remain (Figures 28-36).

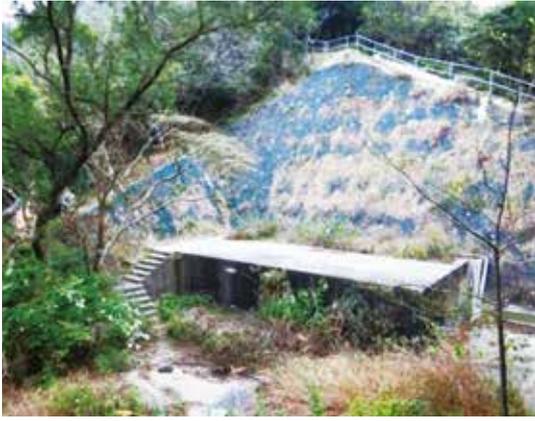
Figure 33: The water tank remains at Shatin Pass (photo by author in 2014).

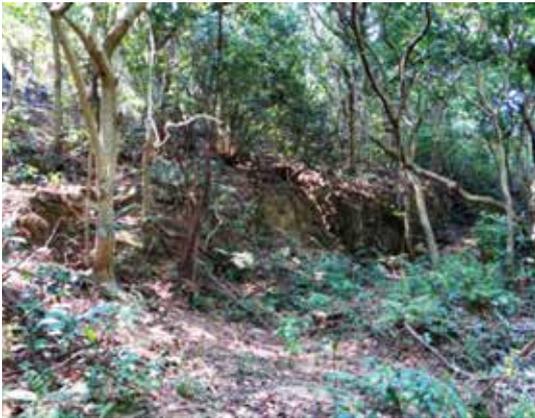
Figure 34: The cutout of HQ shelters near the trail from Shatin Pass Road to Unicorn Ridge (photo by author in 2014).

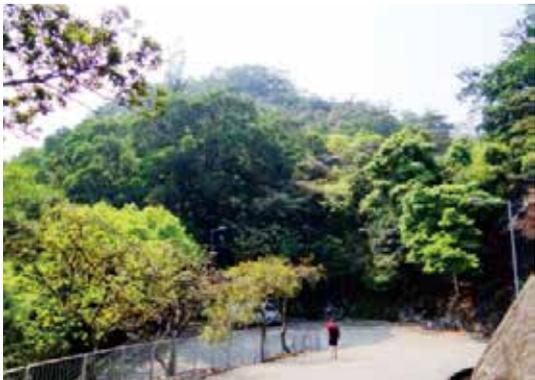
Figure 35: Three HQ shelters located above the corner of Shatin Pass Road near the trail to Unicorn Ridge (photo by author in 2014).

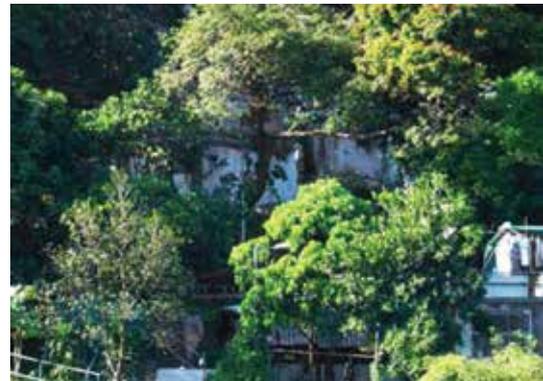
Figure 46: Demolished accommodation shelters on the upper level (photo by author in 2008).

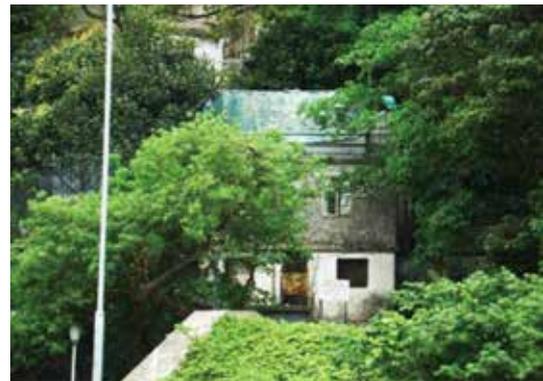
Figure 47: The existing Bn HQ shelter. The brick house on top of it was possibly added by squatters after the war (photo by author in 2010).

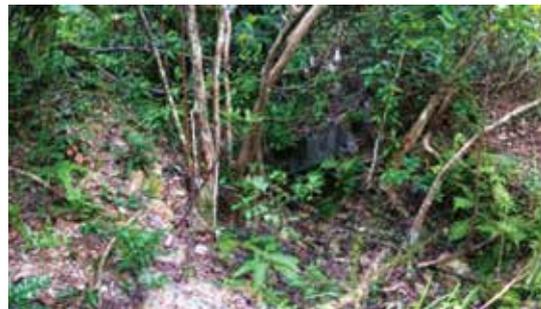
Figure 60: Remains of a concrete ventilation shaft near the shelter cutout (photo by author in 2019).

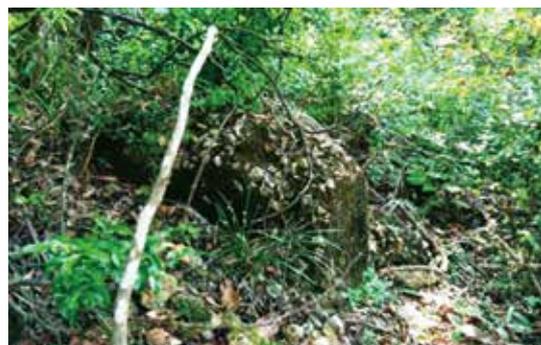
Figure 61: Remains of the shelter wall at the site (photo by author in 2019).

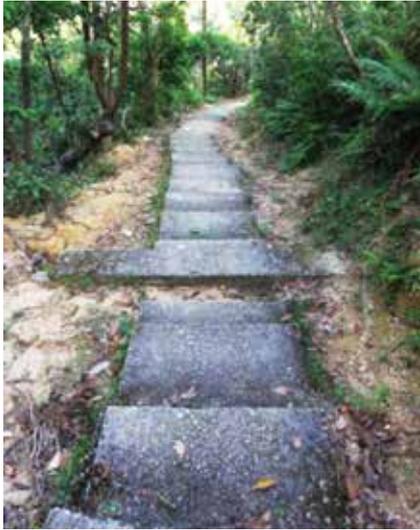
Figure 62: Concrete steps connecting Golden Hill Road to the HQ (photo by author in 2019).

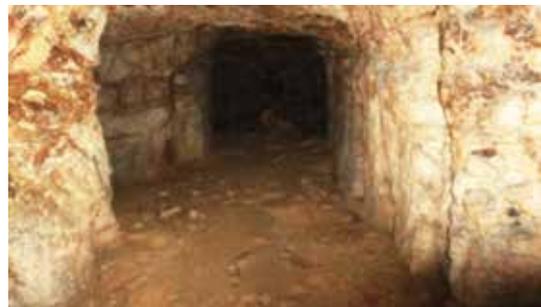
Figure 66: A large Japanese tunnel network built next to the HQ site (photo by author in 2019).

During their occupation of Hong Kong, the Japanese built many tunnels along Golden Hill Road (**Figures 66-68**). Most of these tunnels were sealed by the government’s slope maintenance service and are inaccessible today. But a large cave possibly used by the Japanese as a HQ still exists. A large complex of tunnels was also found next to the Bn HQ site. This indicated that the Japanese also considered Smuggler’s Pass a strategic position and placed a sizable garrison there.

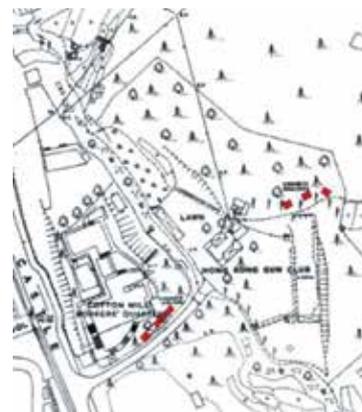
Figure 70: 1957 Survey map showing the concrete shelters at Skeet Ground (1:1200 144-SE-D Ed 1957).

Skeet Ground's main building and shooting field are also clearly visible on the aerial photos. The 1949 photo (**Figure 71**) showed a few shelters, while the 1956 photo (**Figure 72**) showed four shelters along a hillside whose arrangement was similar to that of other HQs. A 1957 survey map (**Figure 70**) showed three concrete shelters on Skeet Ground (Hong Kong Gun Club) and four shelters near Castle Peak Road. It's not unusual for a survey map to miss some military structures that were difficult to detect on aerial photos. Six to eight shelters at this site were arranged in two groups. All were built on the reverse slope of the hillside.

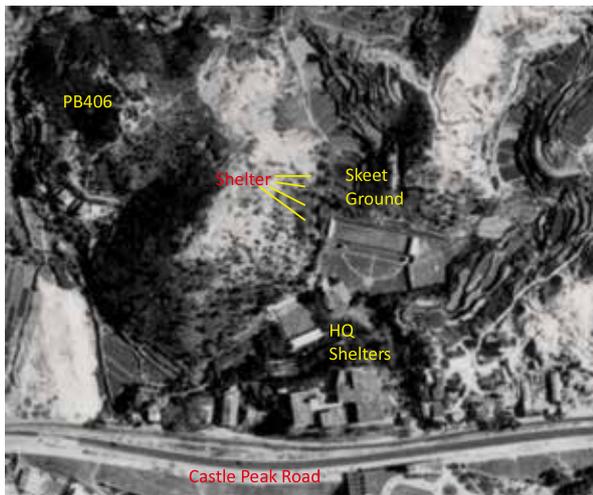
Figure 72: Skeet Ground on a 1956 aerial photo shows three HQ shelters. The shelters near Castle Peak Road are invisible. Note the new buildings and firing range built there after 1949 (1956 R.A.F. aerial photo 81A 560 0009).

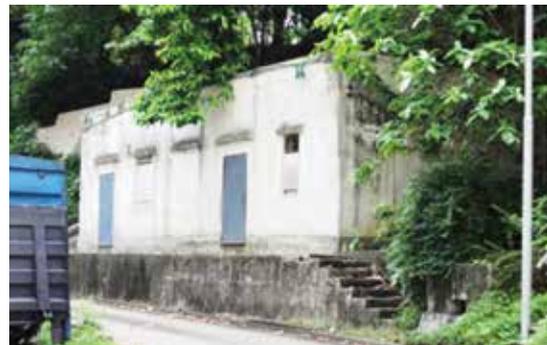
Figure 74: A shelter-like structure at the Salvation Army site (photo by author in 2010).

The Salvation Army site in Kwai Chung is visible on the 1949 photo, which meant it existed before the war. The main buildings and site layout were the same as today. Some shelter-like buildings still exist there (**Figures 73-75**). There is no documentation of the British having used this site during the war. However, as there were few well-constructed buildings in the area by the time the war broke out, the British could have used it to support their defence of Kwai Chung.

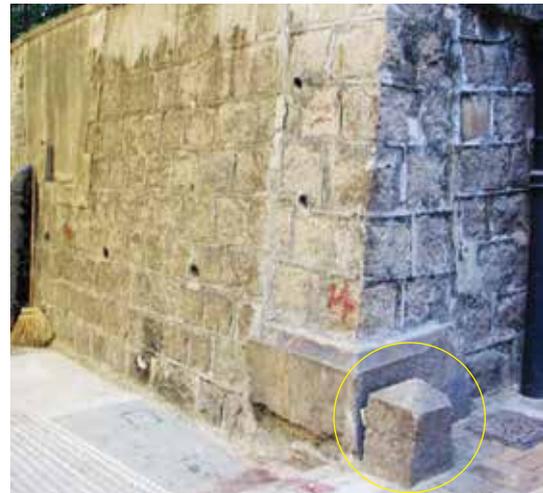
Figure 2: WD No.5 boundary stone remains on Haiphong Road outside Kowloon Park today. It marked the land as War Department property before (photo by author in 2006).

Whitfield Barracks is bordered by Nathan, Canton, Austin, and Haiphong Roads as WD Lot No. 5. (**Figure 2**) In 1970, its southern section was redeveloped into Kowloon Park. Most of its buildings were demolished during this redevelopment, but some were preserved as exhibition centers or storage facilities. (**Figure 3**) The northern section was also demolished during the 1980s and became a public swimming pool and Chinese Garden. **Figures 4 to 5** show some remaining buildings of the former barracks. The Kowloon West II Battery was also located inside the Whitfield Barracks. It was converted into a discovery playground inside Kowloon Park (**Figure 6A**).

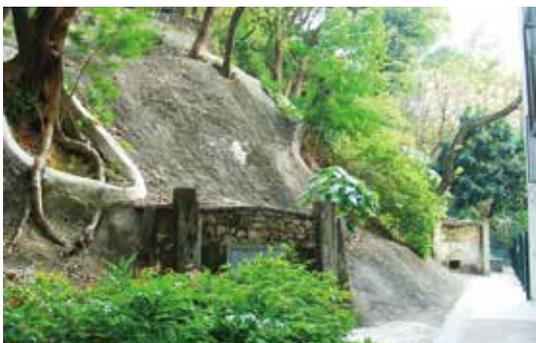
Figure 6B: Air-raid tunnel network below Whitefield Barracks.

A large air-raid tunnel network was built under Whitfield Barracks around the northern section area. Several tunnel portals are still visible today (**Figure 6B**). Some shielded tunnel sections and underground structure also can still be found inside Kowloon Park today (**Figure 6C**).

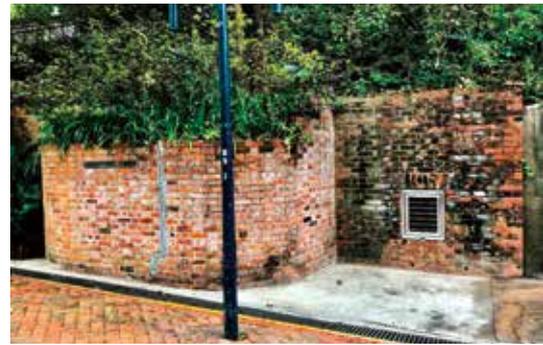
Figure 6C: Blocked tunnel section in Kowloon Park (photo by author in 2018).

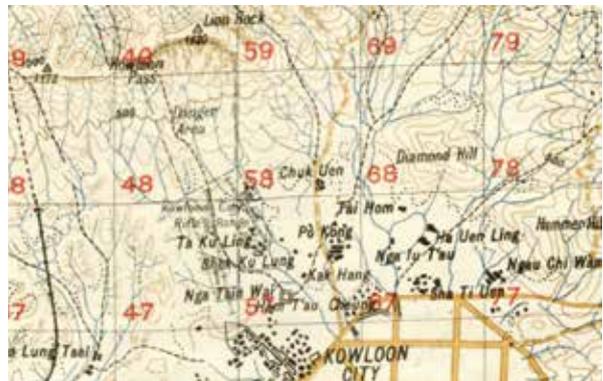
Figure 13: 1922 War Office map showing the Kowloon City Rifle Range under Lion Rock. Note the two ranges marked by length and the restricted “Danger Area” above them.

Kowloon City Rifle Range, with an area of approximately 45 ha, was built under Lion Rock in the present Wong Tai Sin area (**Figures 13 and 14**). It was located near where Ma Chai Hang and Morse Park area today. The site is marked as War Department Lot No. 18 on an old map³. The facility had two rifle ranges constructed in a V-shaped configuration. The left range was up to 1,000 yards (914 metres) long, while the right range was some 600 yards (549 meters) long. Along the hillside were multiple shooting lines set at different distances (**Figures 15 and 16**). This well-constructed rifle range allowed soldiers to practice shooting from close to long distances of up to 1,000 yards. The British used it to host shooting competitions with soldiers visiting from other countries.

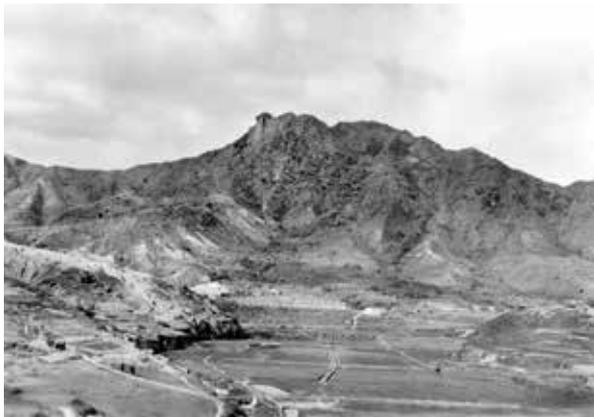
Figure 16: Kowloon City Rifle Range in 1939. Much of the Lion Rock foothill was leveled to build the rifle range (Tim Ko's collection).

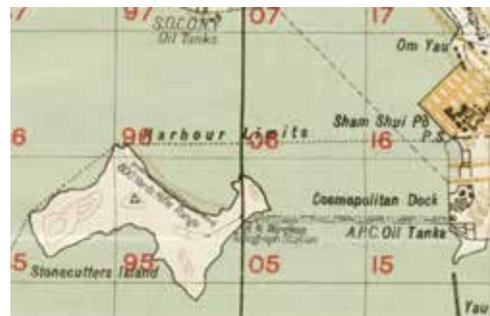
Figure 17: 1922 War Office map showing an 800-yard rifle range on Stonecutters Island.

An 800-yard rifle range, with an area of approximately 2 ha, was built alone on the north coast of Stonecutters Island by 1902 (Editor: National Archive MFQ 1/1363/8) (Figures 17-19). The firing range, in the possession of the PLA since July 1997, now lies on Ngong Shung Road next to Stonecutters Island Sewage Treatment Plant (Figures 20-27).

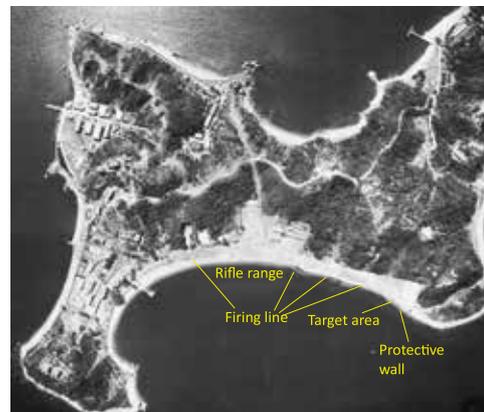
Figure 18: Stonecutters Island Rifle Range is clearly visible on the northern coast of the island in 1963 (Portion enlargement of Hunting Surveys Ltd.'s aerial photo No. 6093 of 1963). [Note that North is upside down].

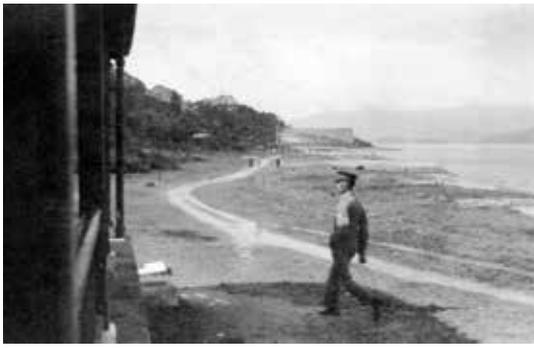
Figure 19: Stonecutters Island Rifle Range in the 1920s. A large stone wall was the stop butt (Tim Ko's collection).

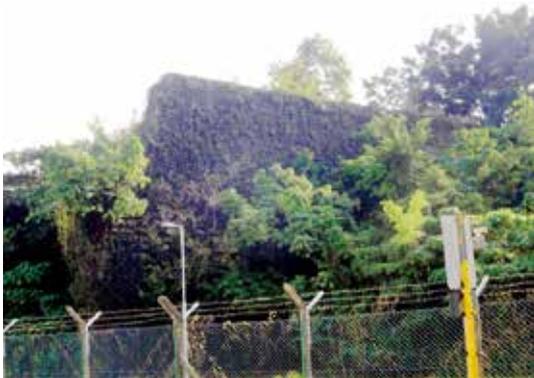
Figure 20: The original stone wall behind the stop butt that stopped all bullets after they had hit (or missed) the targets (photo by author in 2019).

This range was also used after the war, but the firing range was reduced to 300 meters long and further upgraded during the 1980s. Large gate-like concrete walls covered with wood plates built (during the 80s) along the range to capture stray bullets to prevent any damage outside the range. The site was further upgraded (in the middle of 90s) with concrete walls built outside the range to protect the new roads and nearby sewage treatment plant.

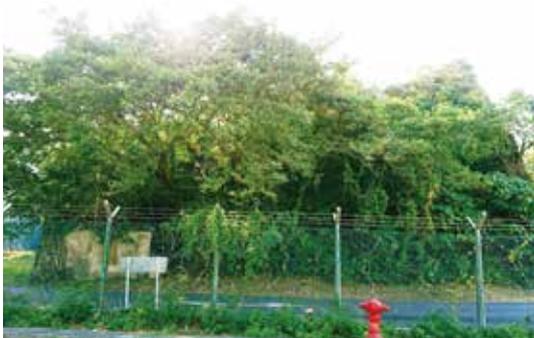
Figure 21: The original target area of the rifle range is now disused (photo by author in 2019).

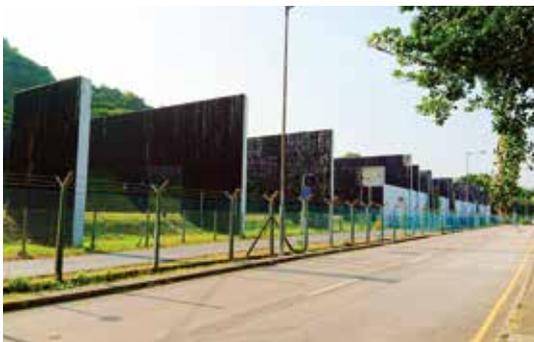
Figure 22: Stonecutters Island Rifle Range today. The white walls were added after 1990s (photo by author in 2019).
